2014 Performance and Progress Report

State of Idaho Nonpoint Source Management Program

**State of Idaho
Department of Environmental Quality**

March 2015

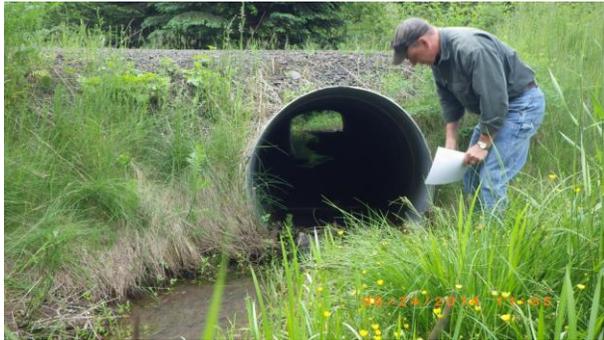
Figure 5. Culvert replaced using project dollars.

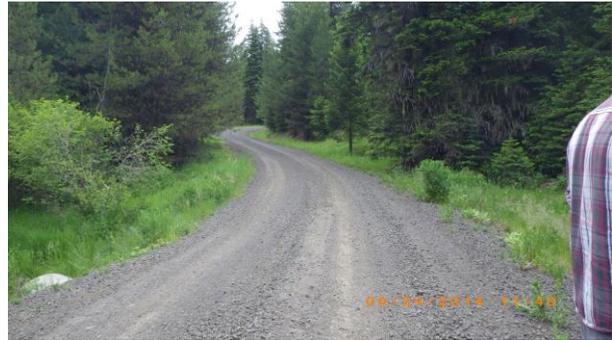
Figure 6. New Soldier Creek road surface.

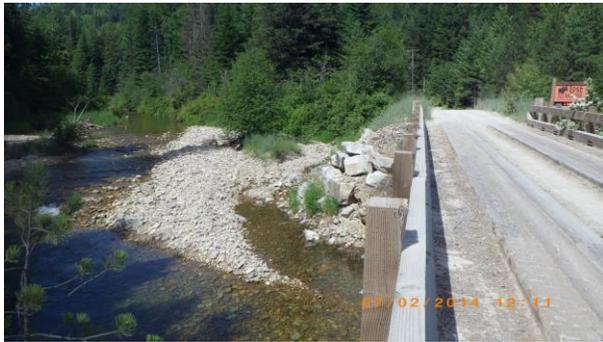
Figure 17. Bridge surface replaced using project dollars.

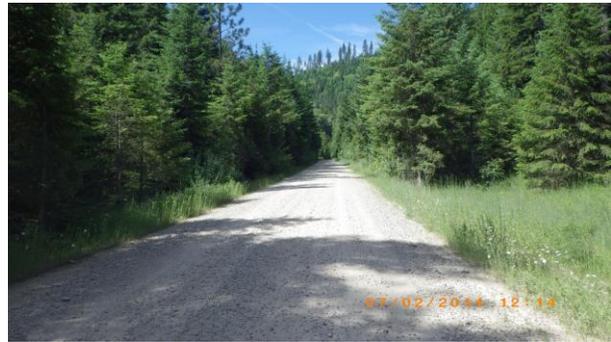
Figure 18. New Latour Creek road surface.

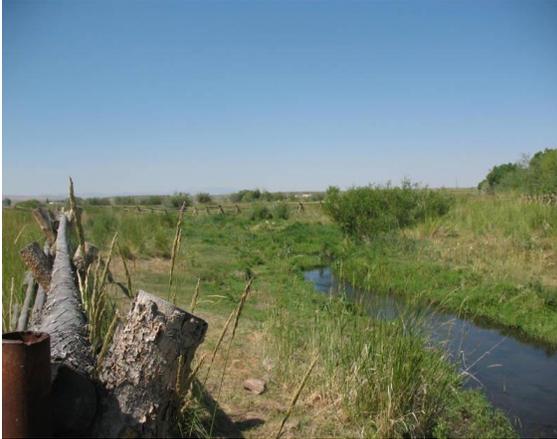
Figure 25. Stable streambanks, renewed riparian vegetation, and decreased pollutant loads were some of the benefits realized after successfully completing this project on House Creek.

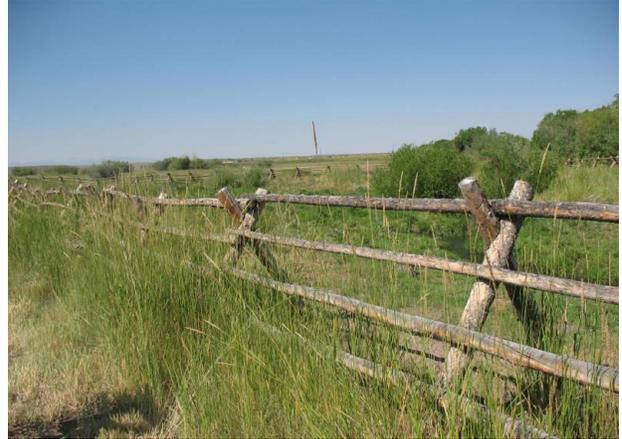
Figure 26. The construction of 11,800 feet of buck and pole fence along House Creek excluded approximately 600 head of cattle from the riparian area. This type of fencing is necessary in areas of heavy snowfall, spring flooding, and marshy conditions where traditional fences can sink or become unstable.

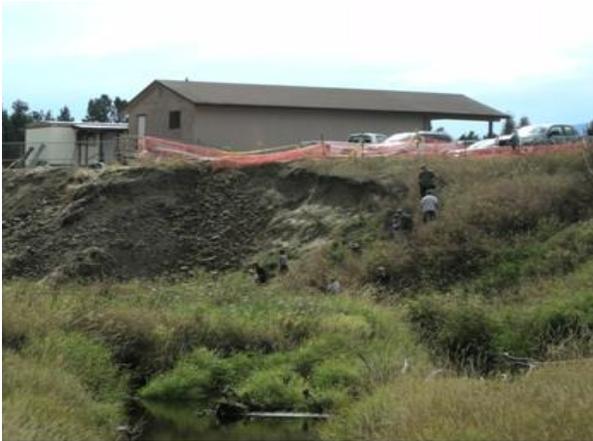
Figure 33. Before the project, this section of streambank had become unstable due to realignment of Boulder Creek for driveway construction.

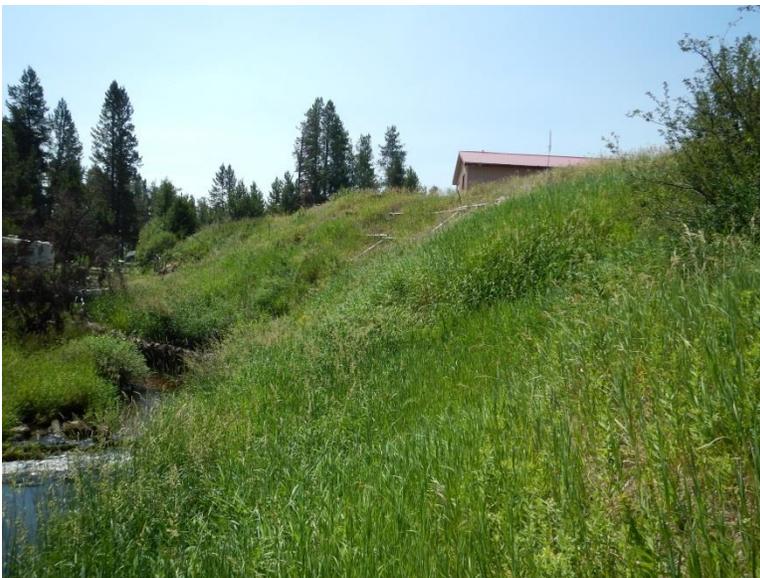
Figure 35. This photo from the 2014 site visit shows several years of bank stability and well-established vegetation. The cribbing has helped to stabilize this outside channel bend.

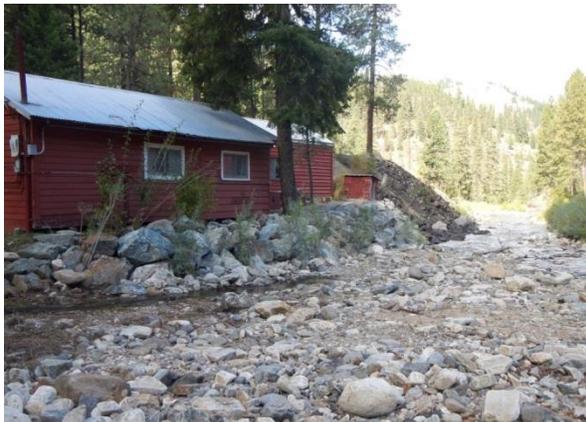
Figure 36. This private landowner has experienced some severe bank scouring along this section of the Little Salmon River. Approximately 150 feet of bank was treated with rock rip-rap interspersed with willow clumps to help stabilize the bank and reduce stream velocities. Unlike cuttings, the use of willow clumps provides lower failure rate and faster site protection. Plantings were completed with the help of 45–50 volunteers.

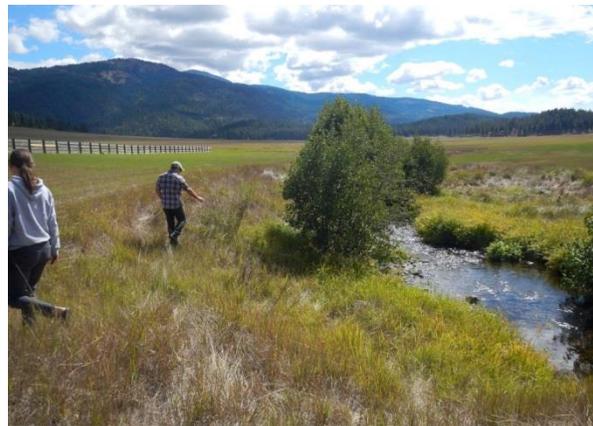
Figure 37. A 2.5-mile section of Round Valley Creek is private land that was historically farmed and grazed up to the edge of the creek. Nearly all riparian vegetation was lost, and the creek became shallow and wide. IDFG and hundreds of volunteers have been working to restore the native riparian habitat. This photo, at the upper end of the private reach, shows some of the first treatments given to Round Valley Creek.

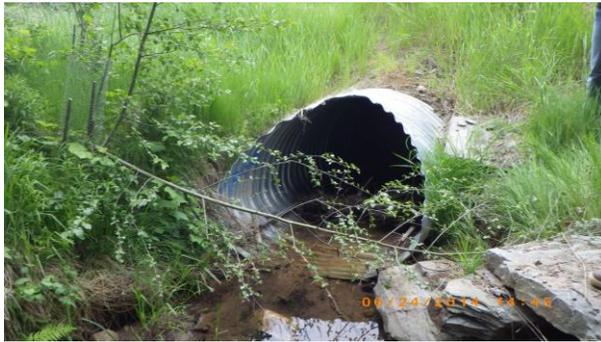
Figure 47. Culvert replaced using project dollars.

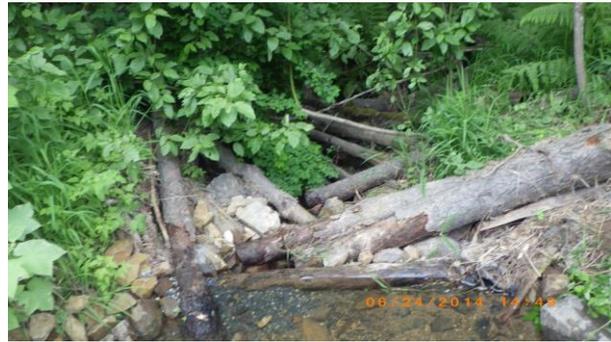
Figure 48. A series of drop structures below the culvert were installed by the Coeur d'Alene Tribe fisheries personnel to provide jump pools for the migrating fish.

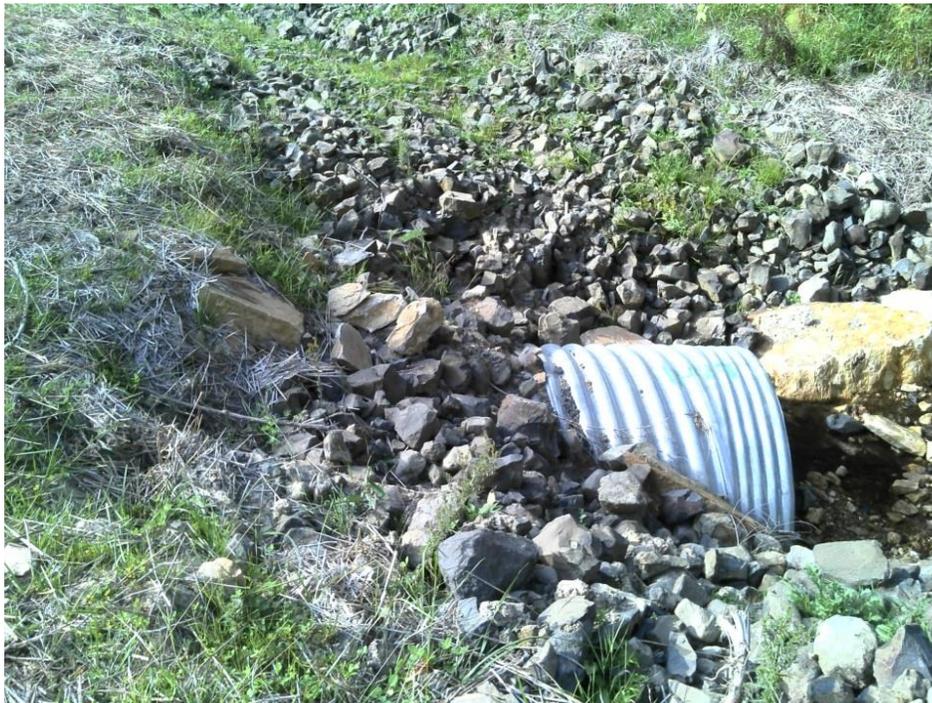
Figure 52. Culvert replacement.

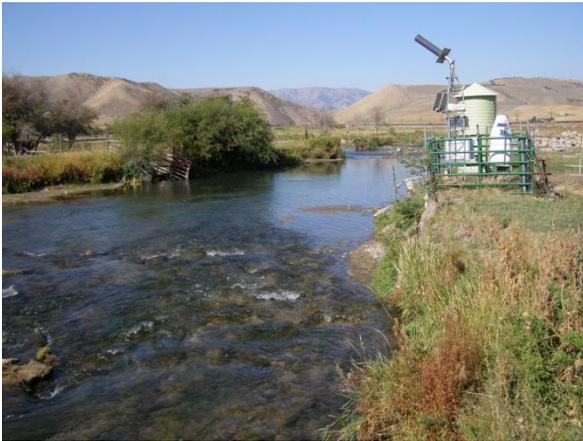
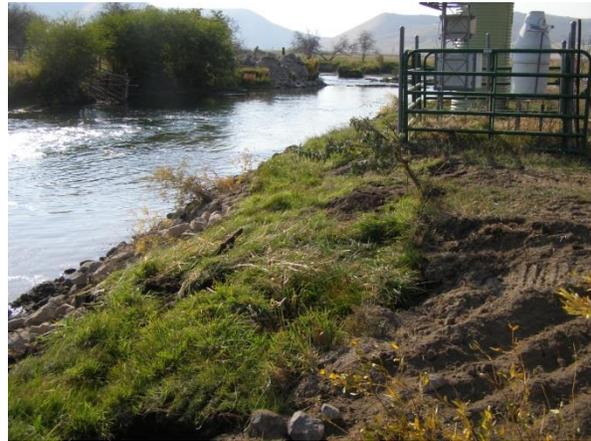
Figures 53 and 54. Streambank condition near the Topaz Gage Station before restoration (left), and a view of the same site after restoration of the streambank (right). A stream barb and toe rock were installed, willows were planted, and sedge mats were placed on the bank.

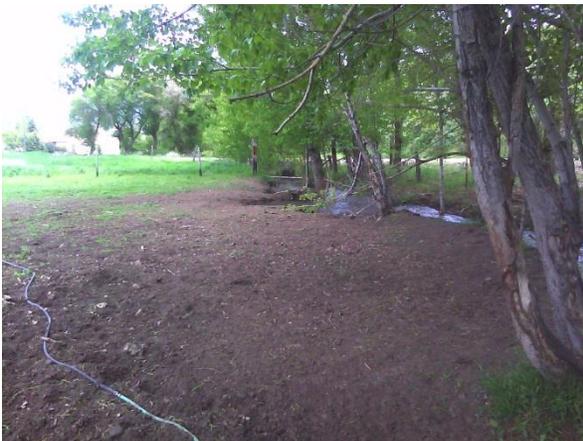
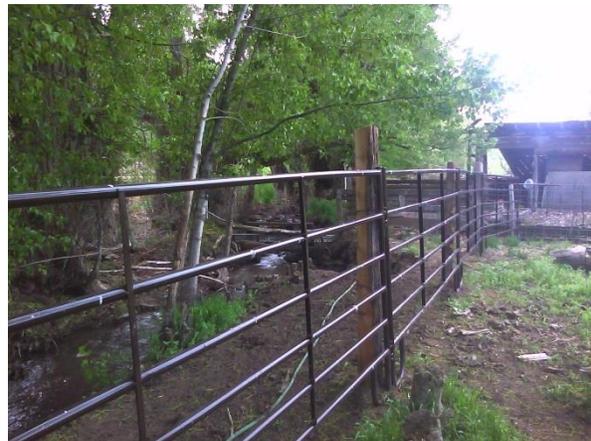
Figures 55 and 56. A downstream look at the streambank before installing the exclusion fencing (left), and an upstream look after the exclusion fence was installed (right).

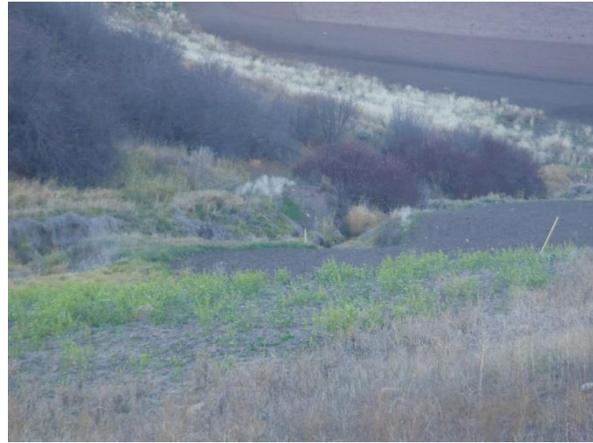
Figure 85. The photo shows how close to the stream edge the landowner farms.

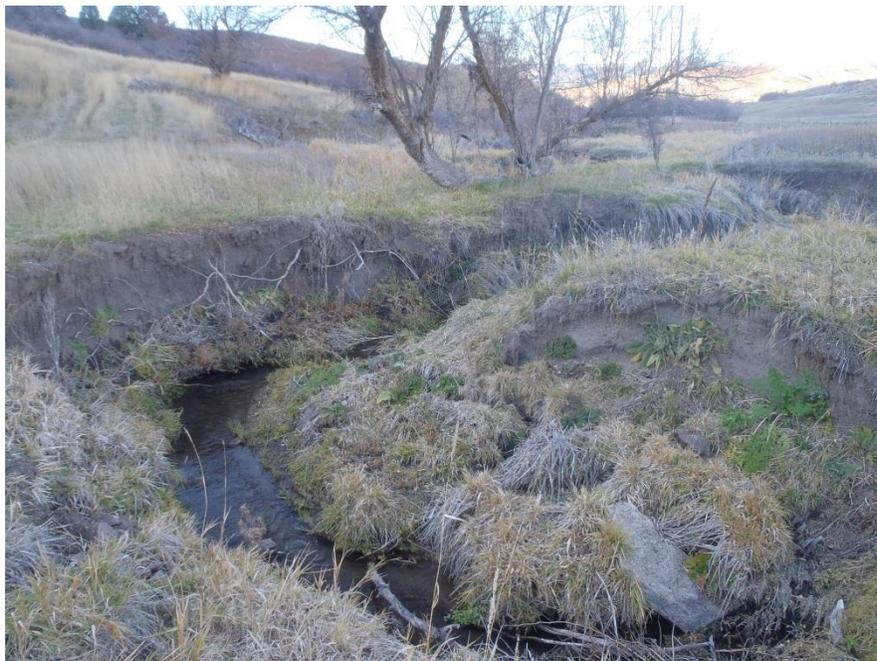
Figure 86. The stream channel has become incised through the property.

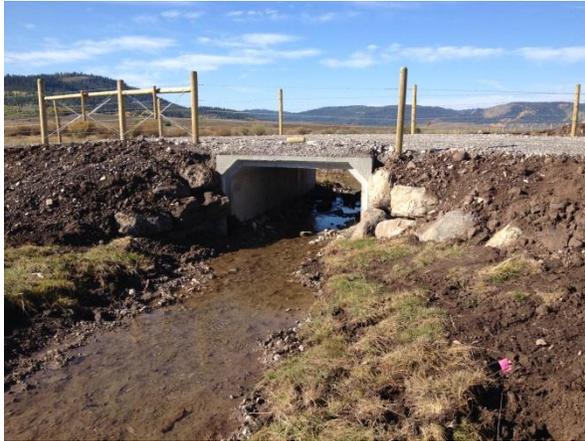
Figure 87. A new box culvert replaced a decrepit crossing.

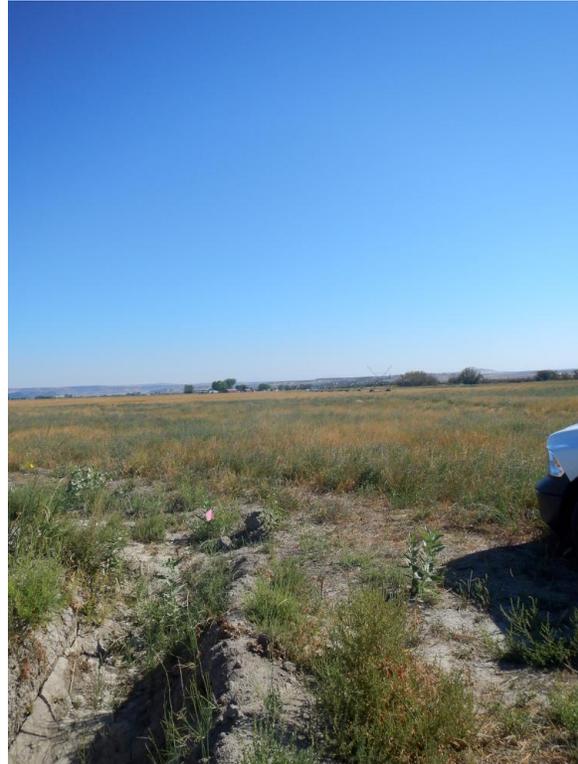
Figure 95. Historically, these highly erodible acres were flood irrigated through a pond and ditch system. This practice resulted in significant water loss and erosion. Irrigation return water discharged directly to Castle Creek, which runs in the tree line seen in the background. Irrigation conversion and leveling ditches on these 113 acres will result in less water removal from Castle Creek and a decreased sediment load in the water discharged back into the creek.

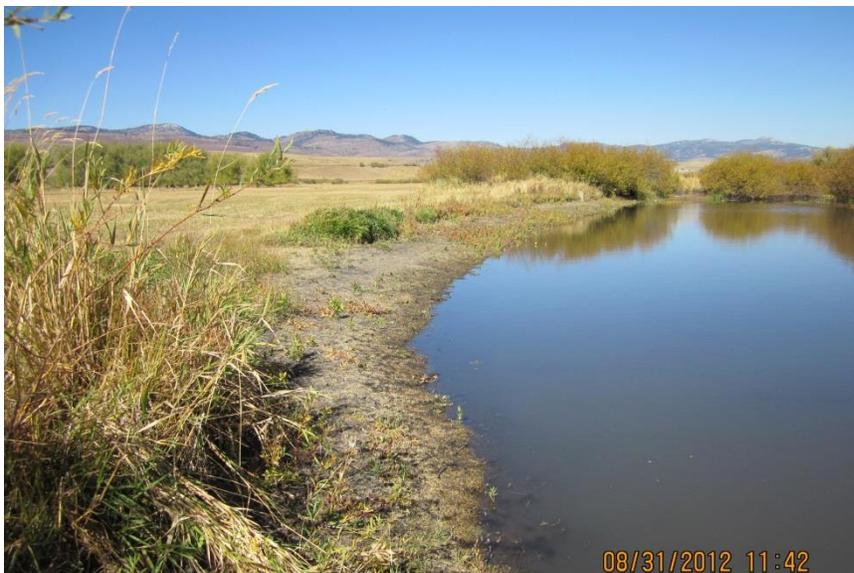
Figure 97. Barren banks upstream of the diversion. Woody vegetation will be planted along these banks.

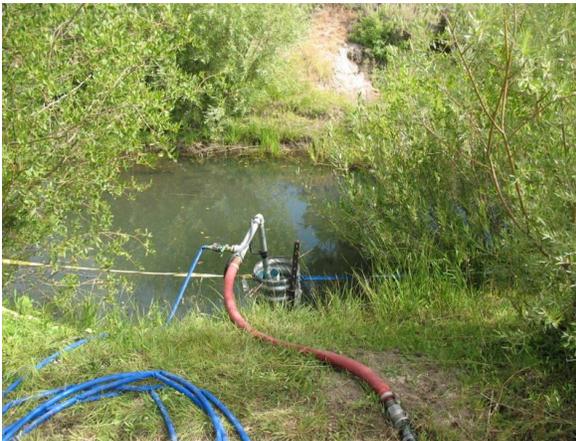
Figure 106. A new 30-gpm solar-powered pump replaced an old diesel-powered pump. The blue hose attached to the side of the pump is used by operators to wash off the solar panels, when needed, to maximize efficiency.

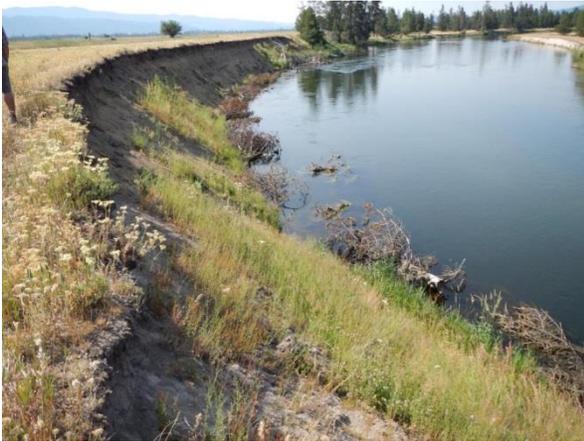
Figure 119. Alzar students helped select the trees that were planted and placed a revetment at the toe of this eroding length of bank. The revetment will be enhanced and more securely anchored to the bank in the future. Willow poles that were planted along this bank had a high mortality rate. In response, alternative techniques were recommended to achieve good soil-to-stem contact and to keep live cuttings viable for a longer period.
