2014 Performance and Progress Report

State of Idaho Nonpoint Source Management Program

**State of Idaho
Department of Environmental Quality**

March 2015

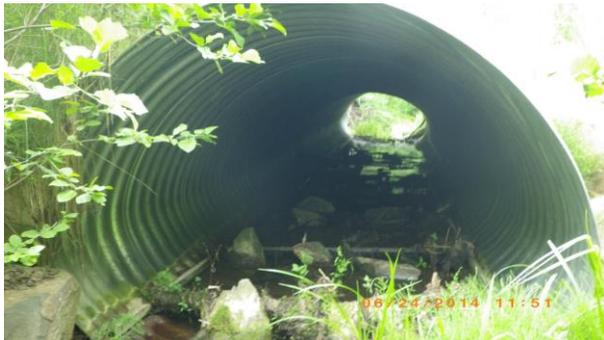
Figure 7. Culvert with a fish ladder installed using project dollars.

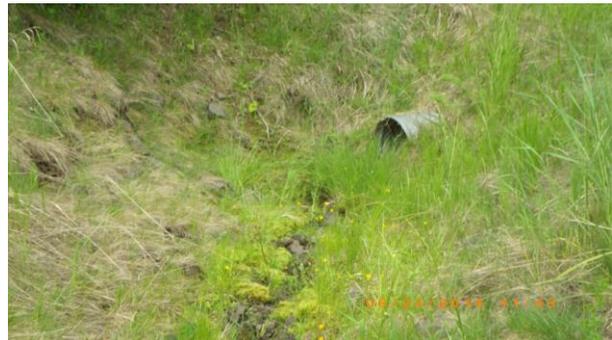
Figure 8. Well-vegetated relief culvert inlet.

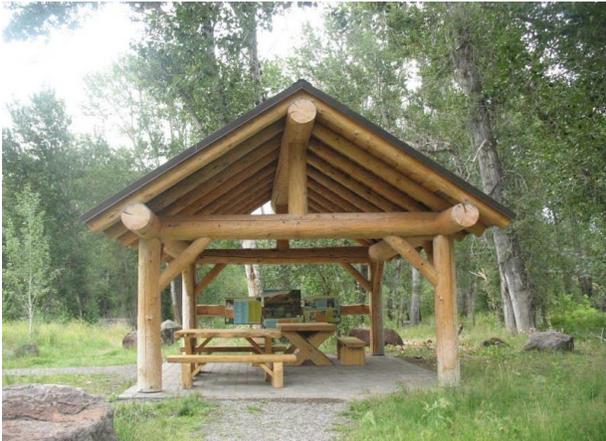
Figure 9. A pavilion and informational kiosk greet visitors as they arrive at the Croy Creek Wetlands boardwalk.

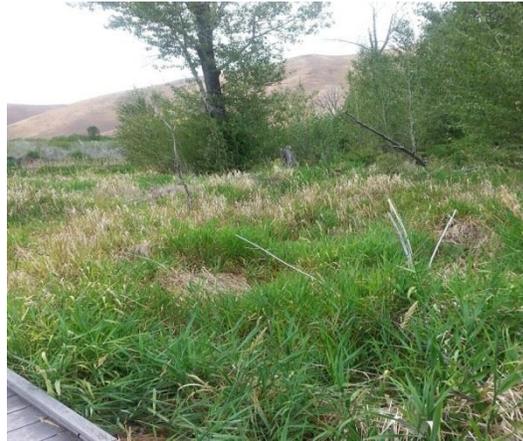
Figure 10. Approximately 5,000 cubic yards of waste material was removed from the project site, which was an old landfill. Efforts to restore the wetland riparian complex were successful.

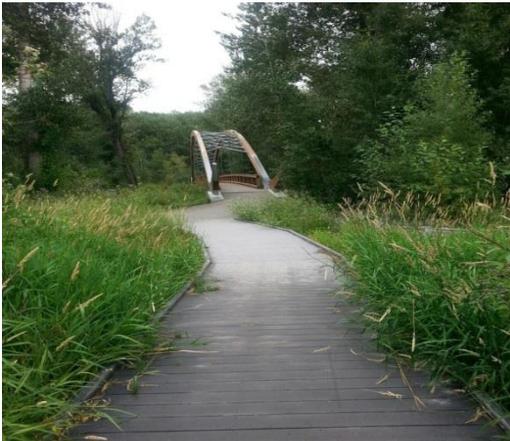
Figure 11. The wetland boardwalk provides the public with opportunities for recreational activities and wildlife viewing, with minimal impact on the resources. An anonymous donor provided funding for construction of a bridge across the Big Wood River, allowing access to additional foot trails.

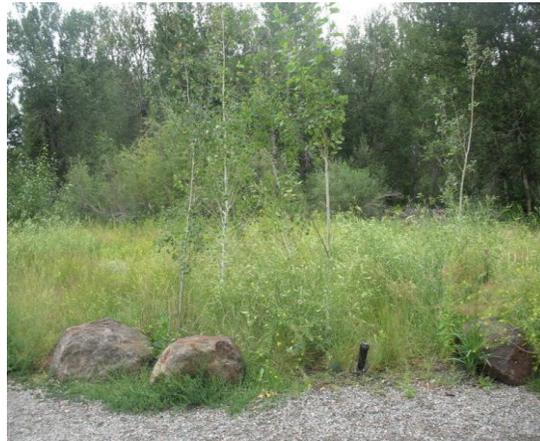
Figure 12. The project provided riparian and native plantings and an irrigation system. Noxious weeds are removed throughout the year.

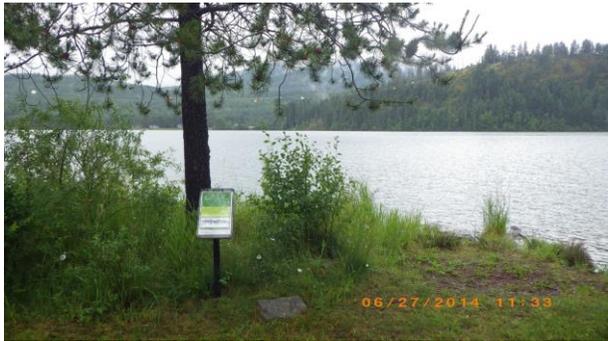
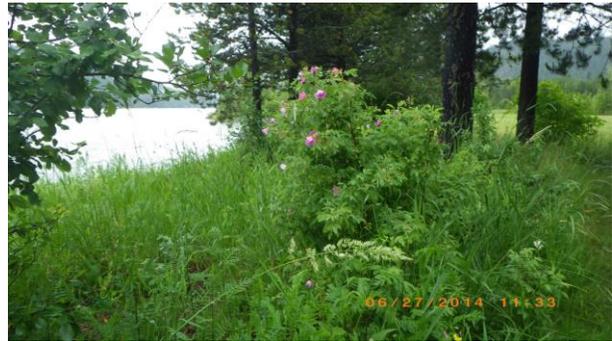
The Dover Bay demonstration riparian buffer BMP has not been well maintained. At the project's onset, the project manager did not understand the importance of getting buy-in from the Dover City Council. The council did not commit personnel for weeding the buffer, so the Lake*A*Syst coordinator maintained it for a few years. The buffer was not weeded this year. New members of the Dover City Council seem more supportive of the demonstration site, so the coordinator hopes personnel will be committed to maintain the site. The Water Life Discovery Center demonstration site has been well maintained. Every year, the Idaho Fish and Game master naturalists spend volunteer hours weeding and maintaining the site. It is in very good condition. The only monitoring done under this project was a postcard survey asking shoreline landowners if they received the Lake*A*Syst book and if they found it useful.

Figure 13 and Figure 14. Riparian buffer at Dover Bay.

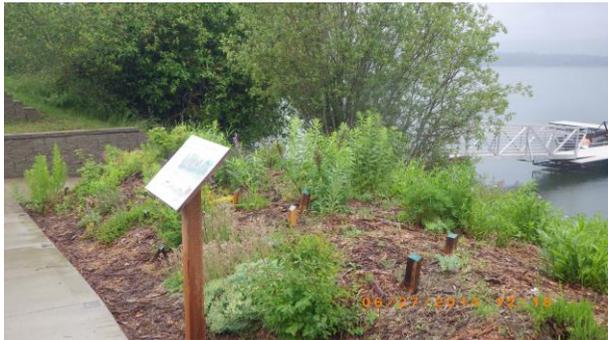
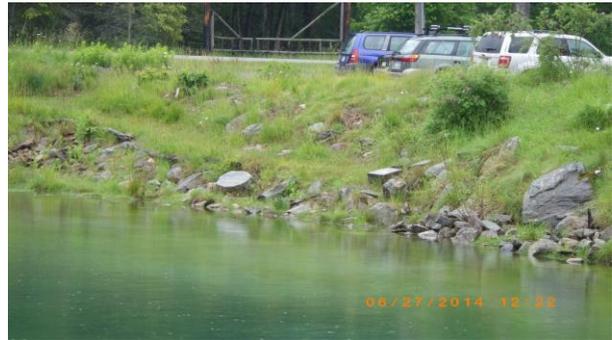
Figure 15. Riparian buffer at the Water Life Discovery Center.

Figure 16. Pond at the Water Life Discovery Center.

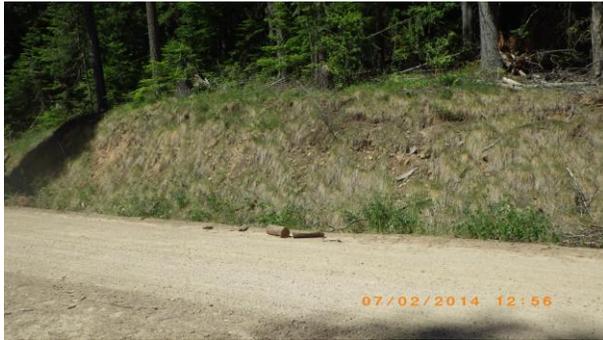
Figure 19. Grass revegetation stabilized this cutslope.

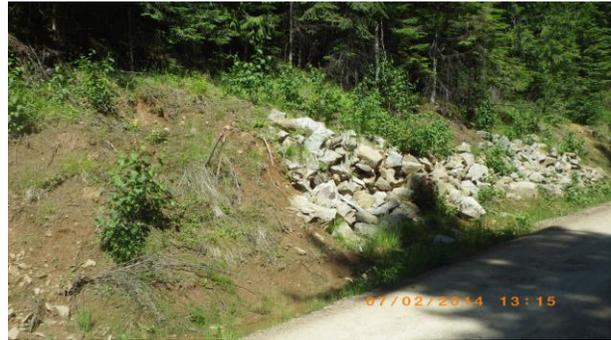
Figure 20. Rock stabilization where grass stabilization was not successful.

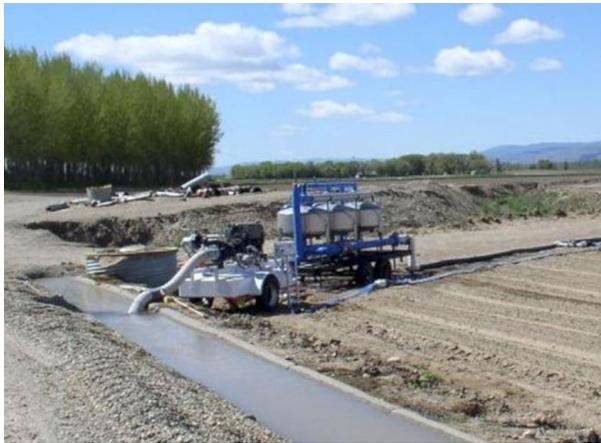
Figure 21. This portable drip irrigation practice will be applied to other fields in the area that are planted to onions in the following years.

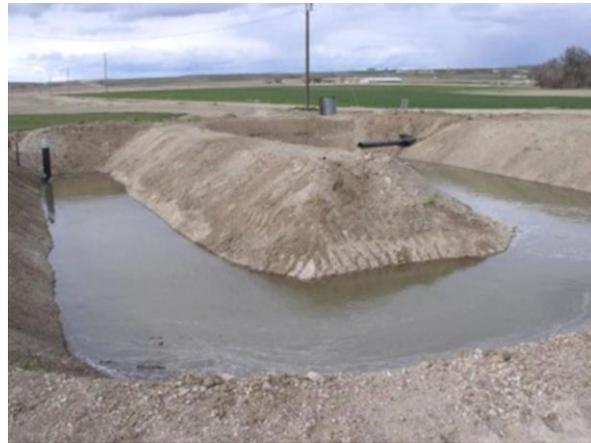
Figure 22. This project consisted of installing a center pivot irrigation system to properly apply irrigation water to the field while also eliminating soil erosion and surface water runoff. A pond was also constructed to temporarily store irrigation water and help clean water from the Farmer Co-op Canal.

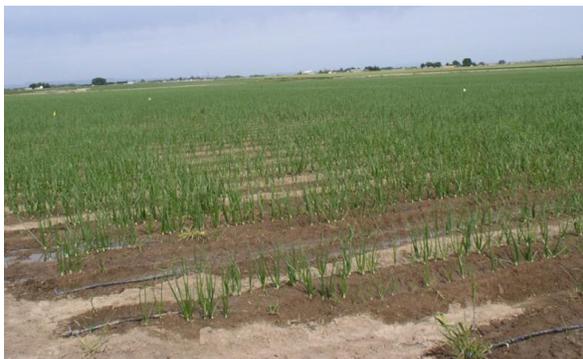
Figure 23. This project installed a drip tape micro-irrigation system to manage adequate water supply while eliminating erosion, deep percolation, and runoff.

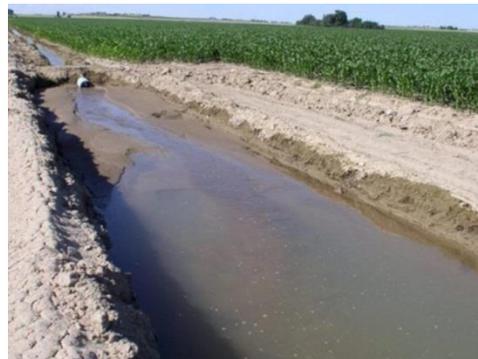
Figure 24. Nine sediment ponds were installed to reduce sediment and attached chemicals from irrigation tailwater.

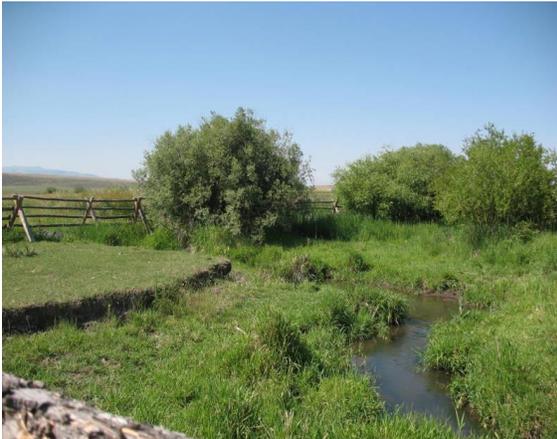
Figure 27. The landowner reports that the benefits of implementing this project far outweigh the costs. The site now provides better cover for wildlife in winter and an improved fishery.

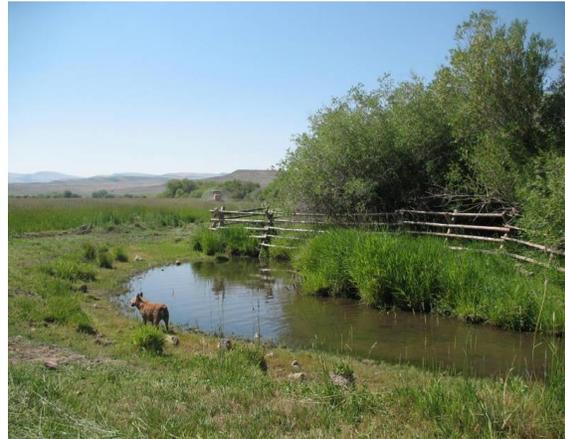
Figure 28. This photograph shows one of the five rock-lined water gaps that were constructed. Although the area is used as a winter-feeding ground for up to 600 head of cattle, the banks along these gaps are stable.

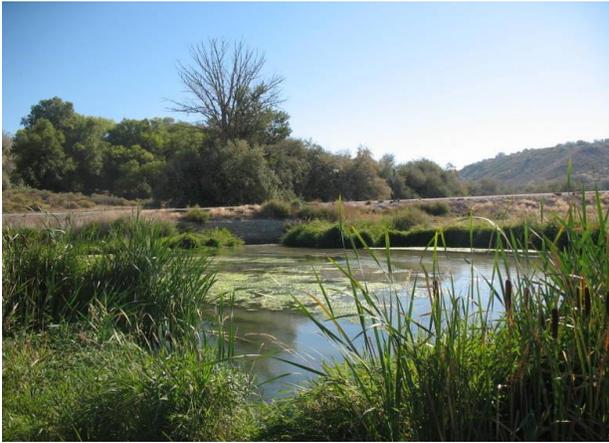
Figure 29. The project included enlarging an existing in-channel pond near Clear Lakes Road.

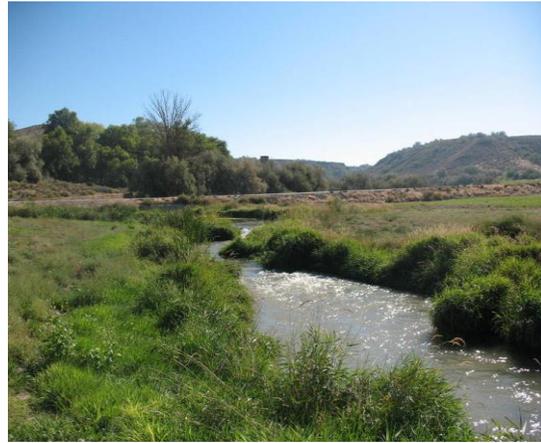
Figure 30. Irrigation return water flows from a large sediment pond into a second smaller pond. The banks of the ponds were planted with vegetation to help filter the water, and approximately 700 feet of Silo Creek streambank was planted to reduce the potential for erosion.

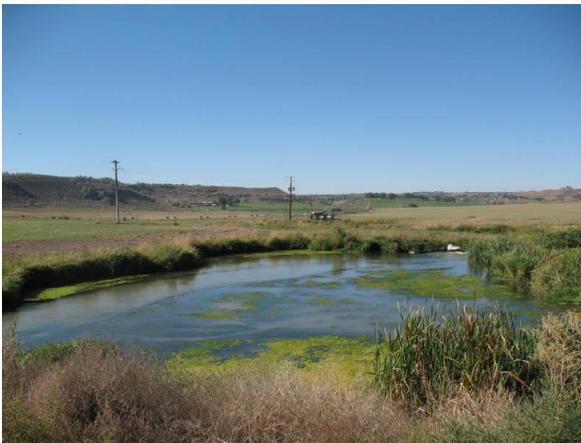
Figure 31. A new landowner installed several pivots on adjacent farmland and plans to install several more in the future. Specialized irrigation pipe was installed to prevent leaks and pollutants from discharging to nearby waters. A 10-year farming lease ensures the land will not be developed over that time.

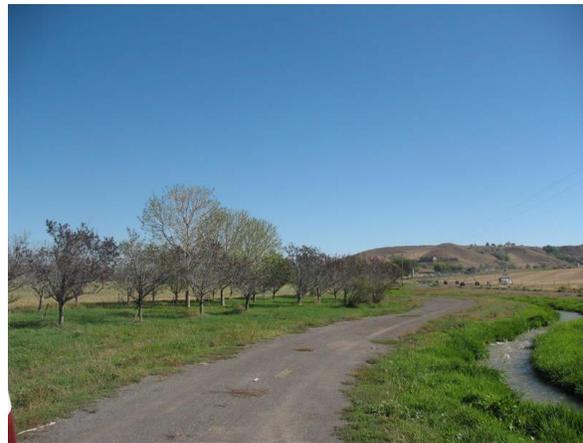
Figure 32. Silo Creek flows from the project site to where it discharges into Mud Creek and eventually into the Snake River.

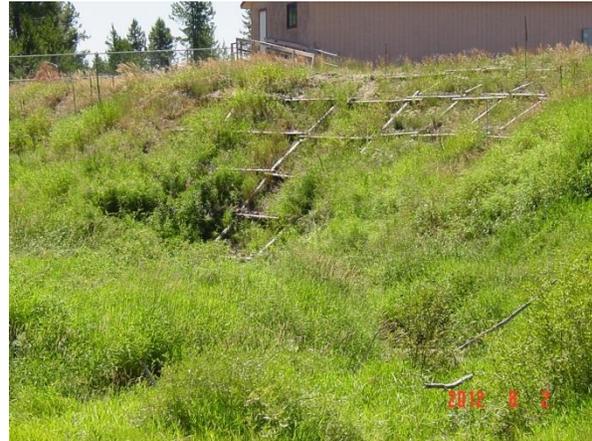
Figure 34. This photo from a 2012 site visit shows the interlocking wood planks acting as a live retaining wall but with less of an environmental impact. Vegetation is planted between the planks. Installation of cribbing and vegetation has allowed the streambank to stabilize.

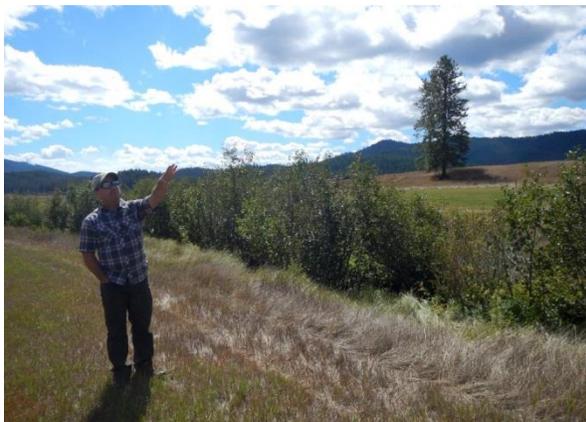
Figure 38. Since the project began in 2000, the creek has narrowed and deepened. The full 2.5 miles have been planted with a density similar to what is seen in this photograph.

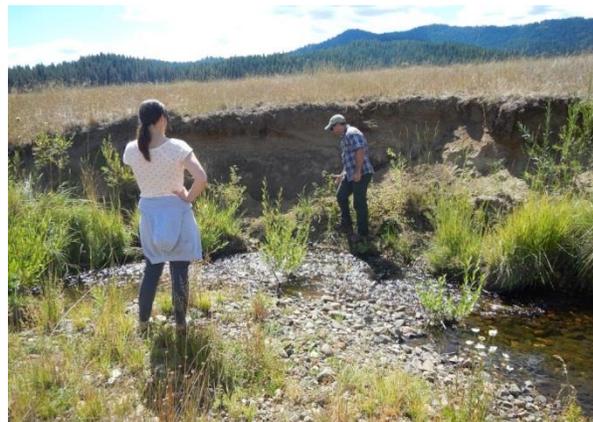
Figure 39. Five-gallon willow clumps were planted in spring 2013 to withstand erosion from spring runoff and to shorten the establishment period.

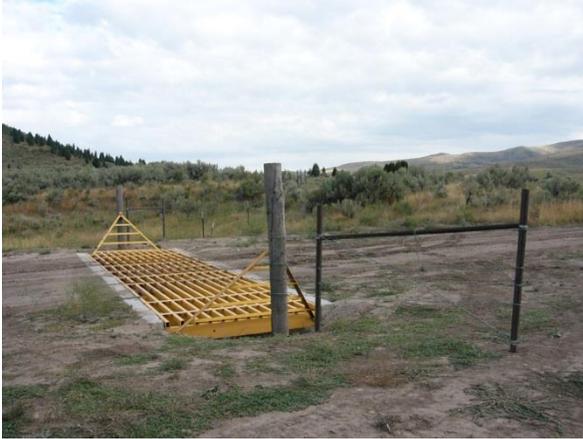
Figure 40. A cattle guard installed in the road where the exclusion fence crosses the road.

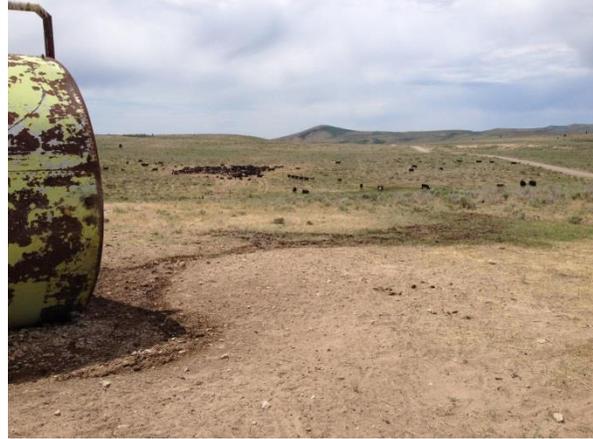
Figure 41. A tank and trough (shown at left) were installed upslope from the river as a source of water for livestock and to prevent trailing pressure on the river near Morgan's Bridge.

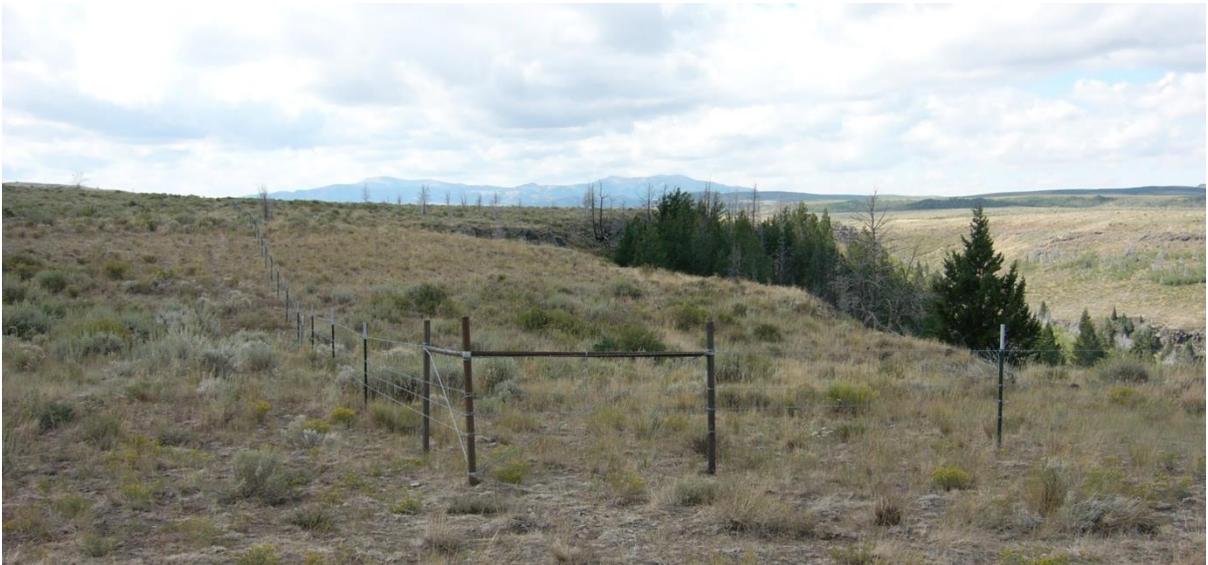
Figure 42. Barbwire exclusion fence installed along the top of the canyon to prevent livestock from accessing the riparian area and the Blackfoot River.

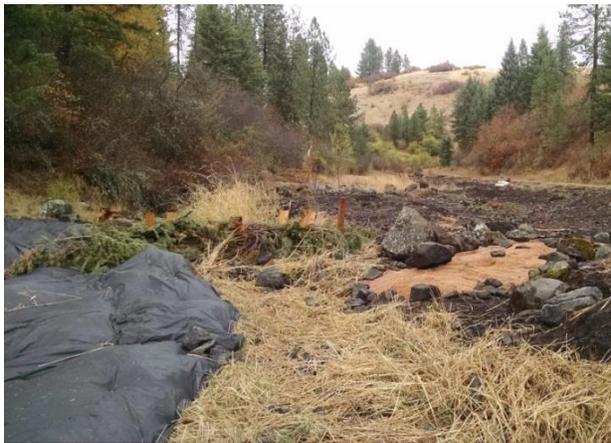
Figure 43. This project established a mock beaver dam to enhance the engineered wetland.

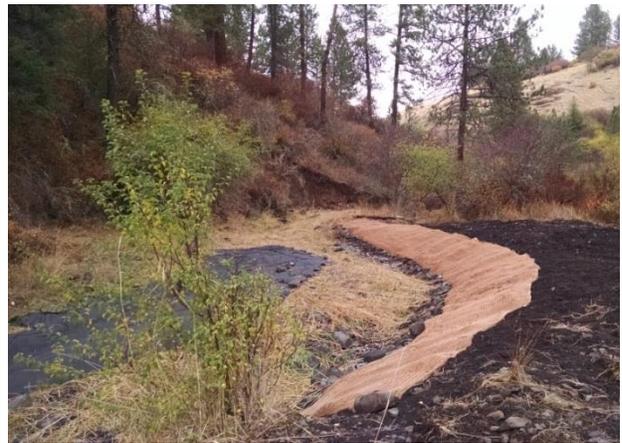
Figure 44. The streambank was resloped and erosion matting installed to help establish a functional floodplain.

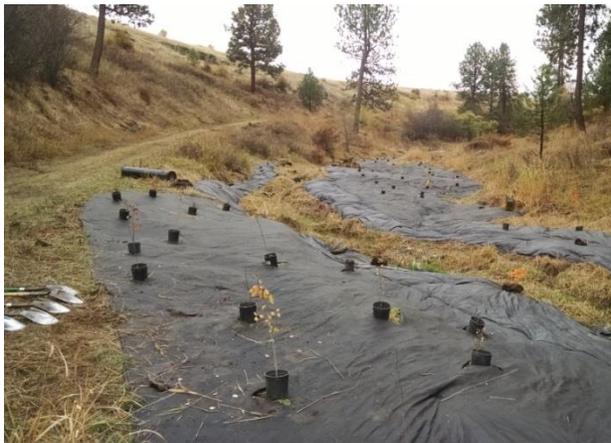
Figure 45. Weed control matting was installed, and a riparian buffer was planted.

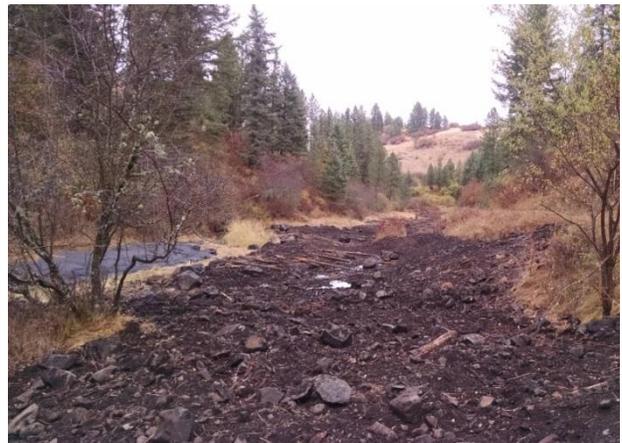
Figure 46. A wetland was established adjacent to Butcher Creek.

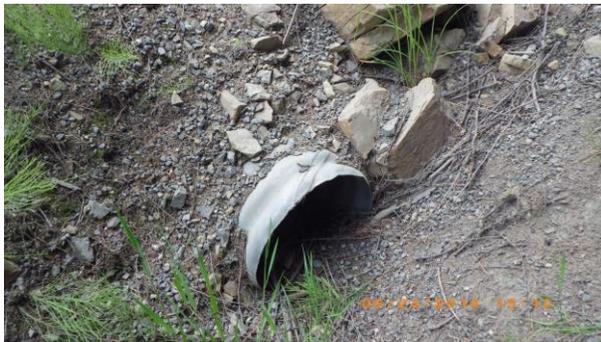
Figure 49. This relief culvert needs to be watched for sedimentation.

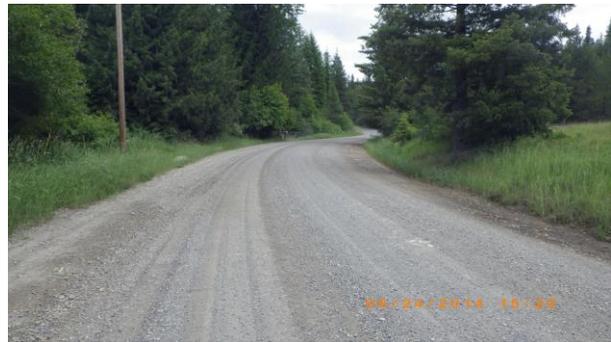
Figure 50. New Hangman Creek road surface.

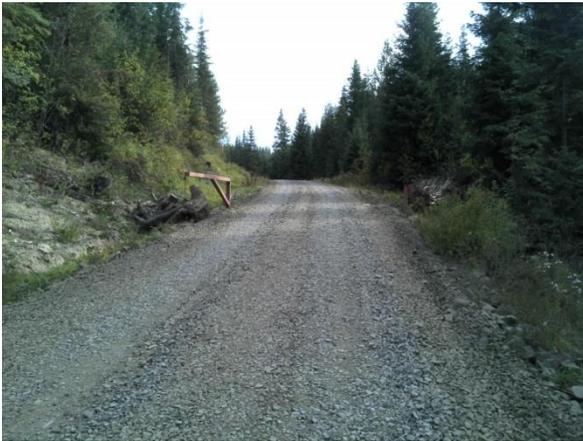
Figure 51. A recently rocked forest road.

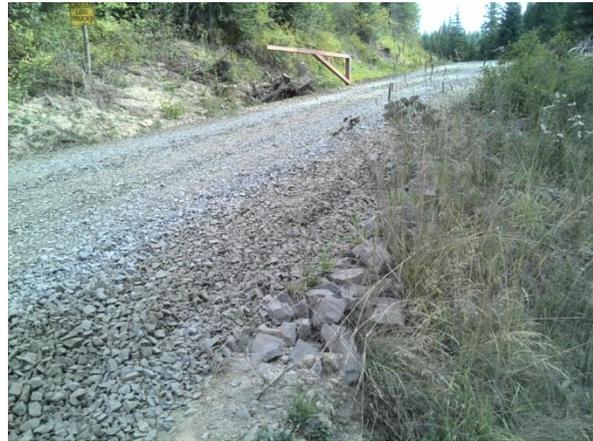
Figure 52. Culvert replacement.

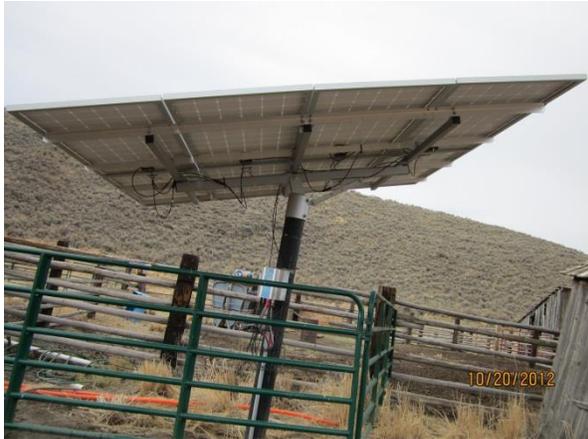
Figure 57. Solar panels power a submersible pump for a system with three water troughs and a storage tank.

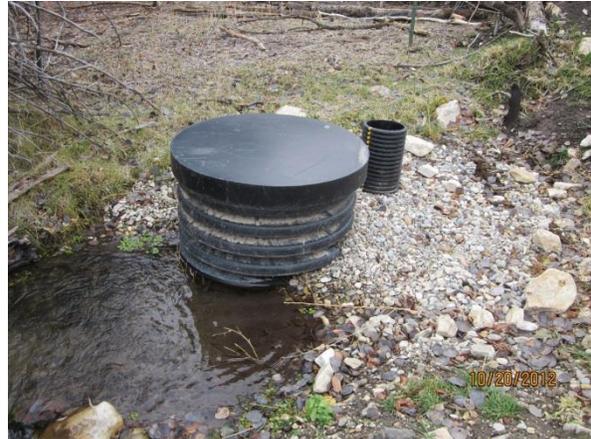
Figure 58. One of two spring collection boxes that provides water for two stock water lines that gravity feed 12 troughs.

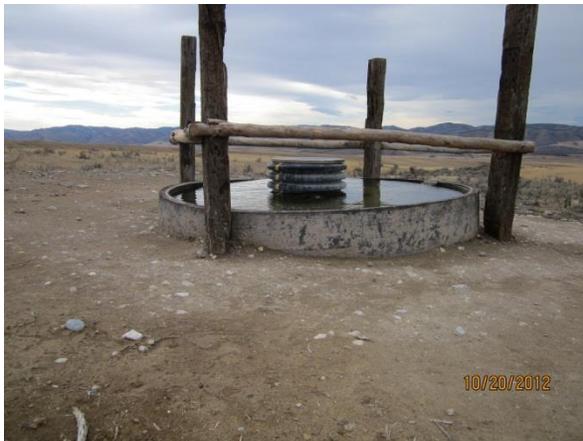
Figure 59. A self-regulating watering trough was installed to ensure a steady supply of fresh water is available to livestock.

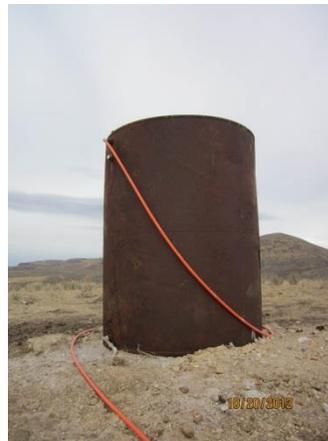
Figure 60. A storage tank capable of providing a 1.5-day supply of water for livestock.

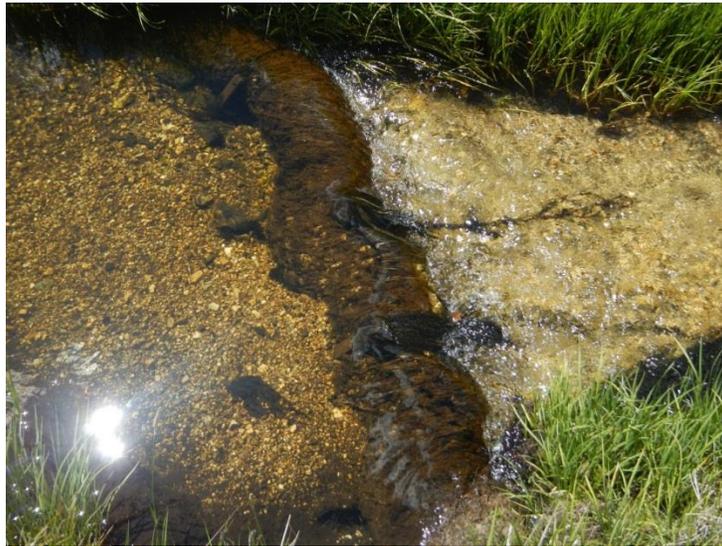
Figure 61. This biology helps create channel complexity and sort substrates in the Casner Creek channel.

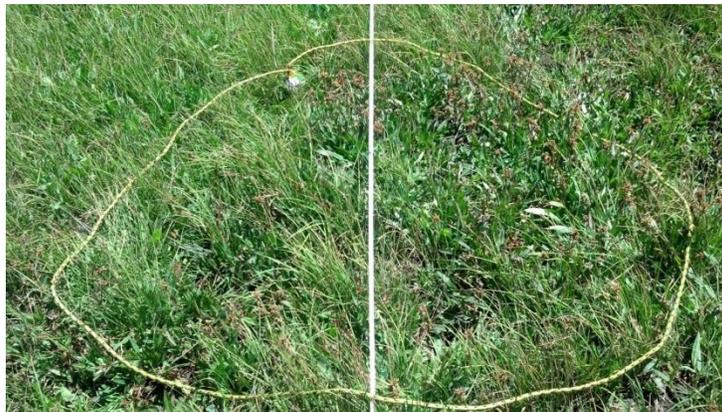
Figure 62. Vegetation has regrown along Casner Creek 3 years after project completion.

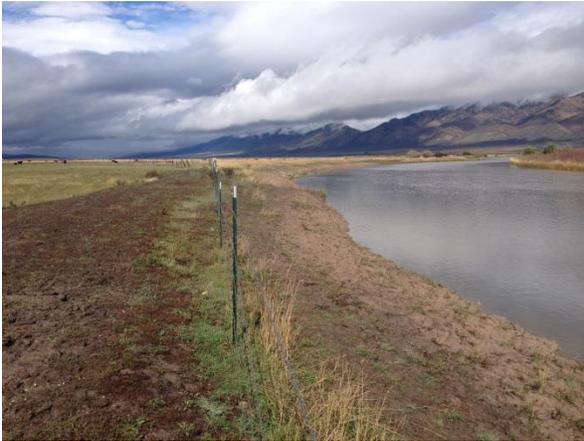
Figure 63. Bank shaping.

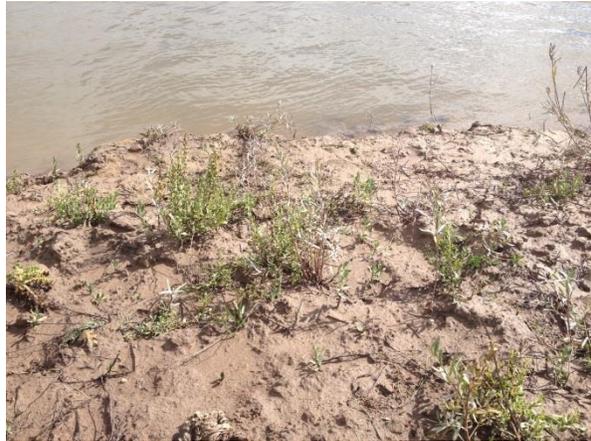
Figure 64. Willow starts taking shape.

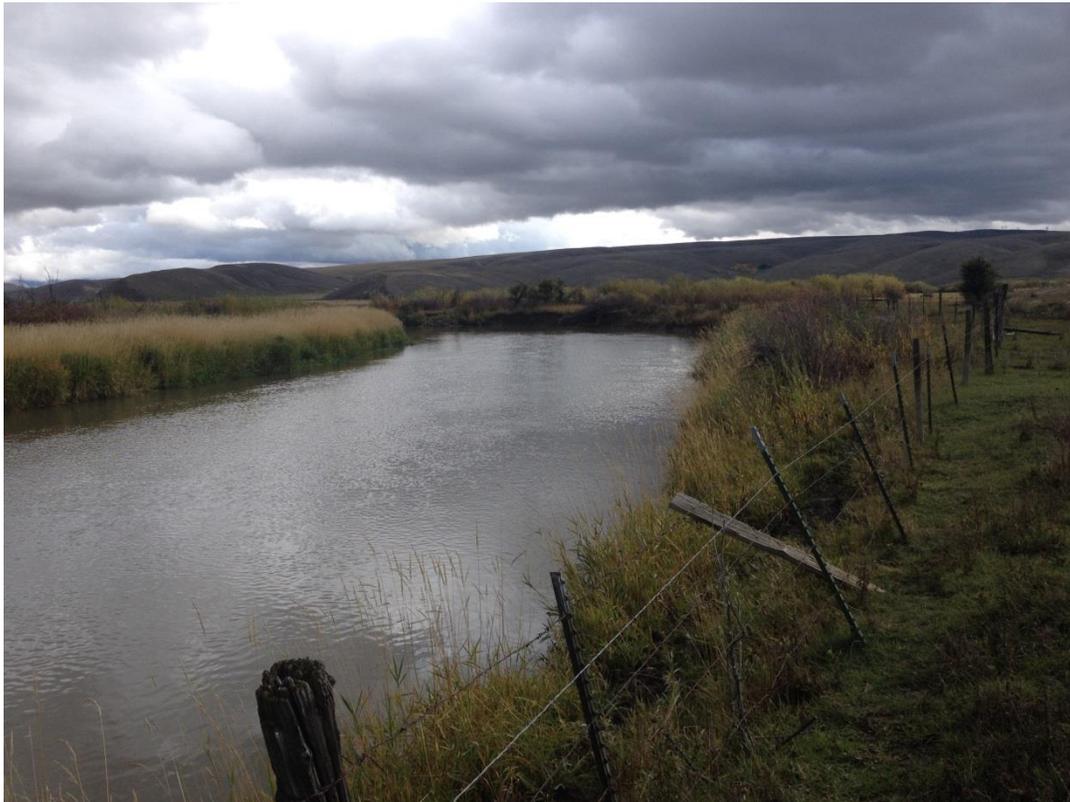
Figure 65. Riparian fencing will limit livestock access to the river.

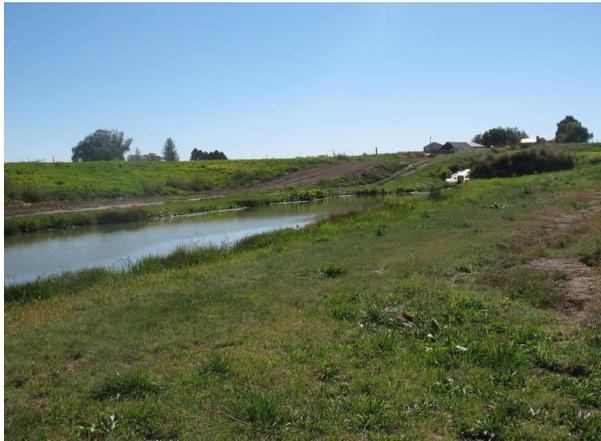
Figure 66. The first cleaning cell in the series of four settling ponds. The field on the left is steep and highly erodible. A center pivot irrigation system was installed in this field as part of the irrigation improvement project.

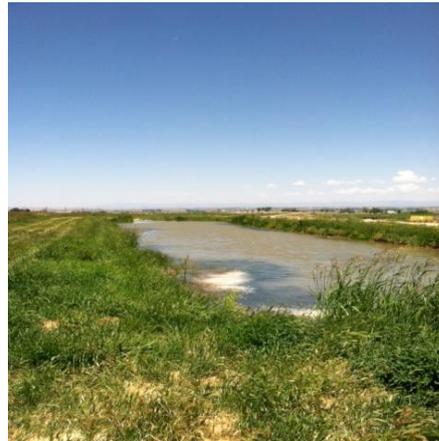
Figure 67. Flow from the first cleaning cell entering the second cleaning cell.

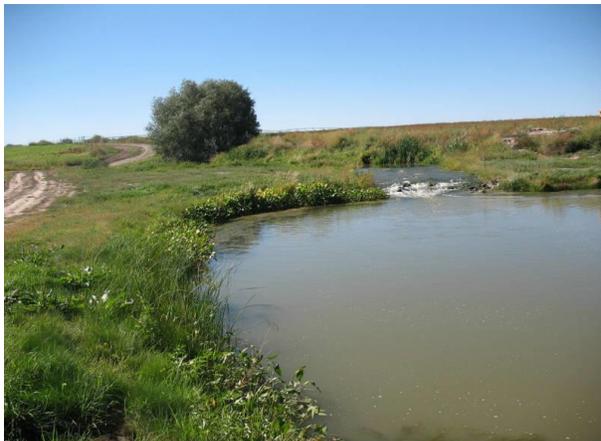
Figure 68. Two large finishing ponds continue the cleaning process before discharging into the canal.

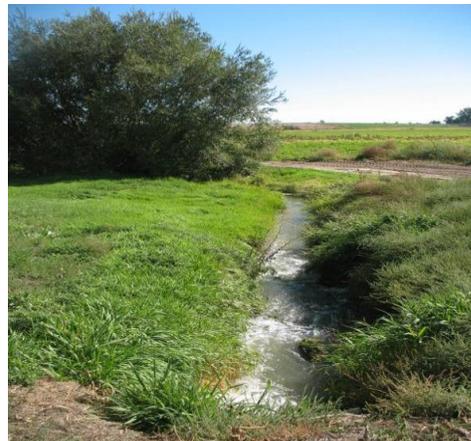
Figure 69. This is the final discharge point of the project. The average flow is 7–8 cubic feet per second.

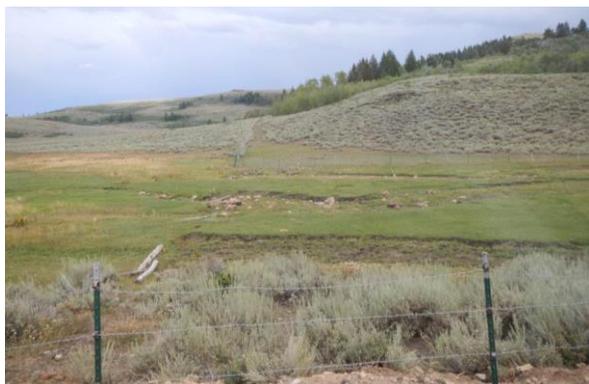
Figure 70. The headwaters of Cold Springs Creek were previously unfenced and cattle freely roamed the area. The fencing helps manage the cattle with a rest rotation protocol that will let vegetation establish and reduce the effect grazing could have on downstream water quality.

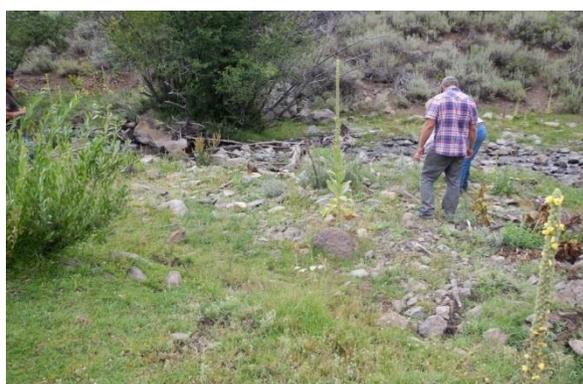
Figure 71. After just one season, fencing and rotational grazing is having a positive impact on riparian vegetation.

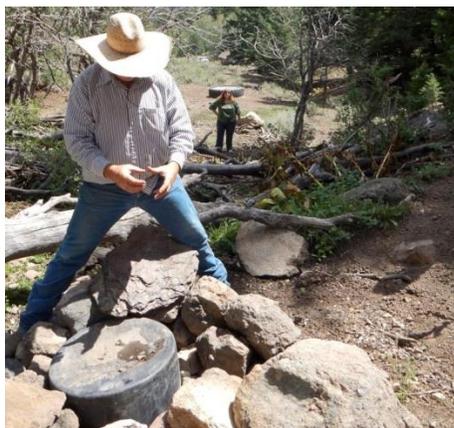
Figure 72. Spring developments provide a clean source of water for livestock and protect the stream from damage and contamination. This spring delivers water by gravity flow to the tractor tire in the background. The spring box consists of a 50-gallon perforated drum with a pipe going from the box to the trough. Concrete seals the bottom of the trough.

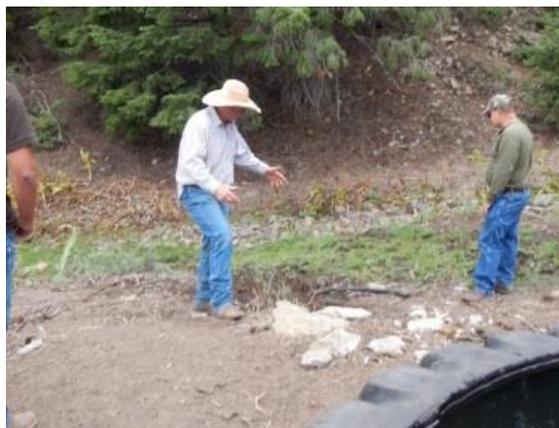
Figure 73. Overflow from the trough returns back to the creek. Providing an off-spring water supply keeps cattle from negatively impacting the wetland and ensures an excellent and plentiful supply of clean water.

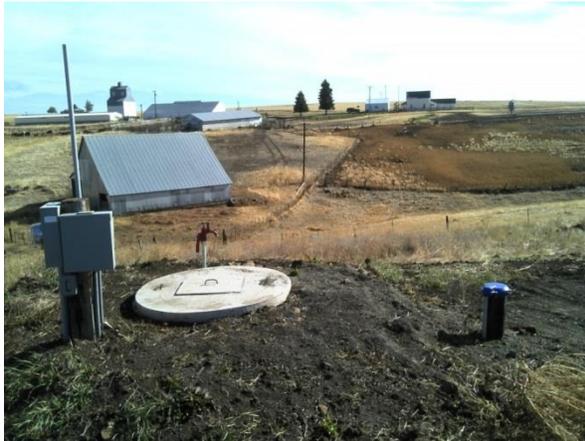
Figure 74. One well and a pump station have been drilled and installed.

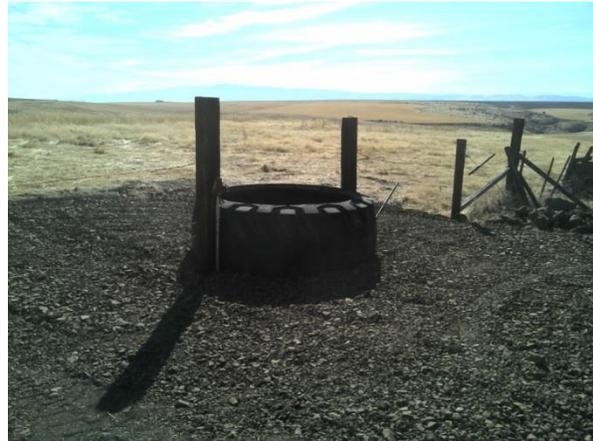
Figure 75. A water trough and heavy use rock pad were installed. Some water lines have been installed, and others will be installed to adjacent troughs.

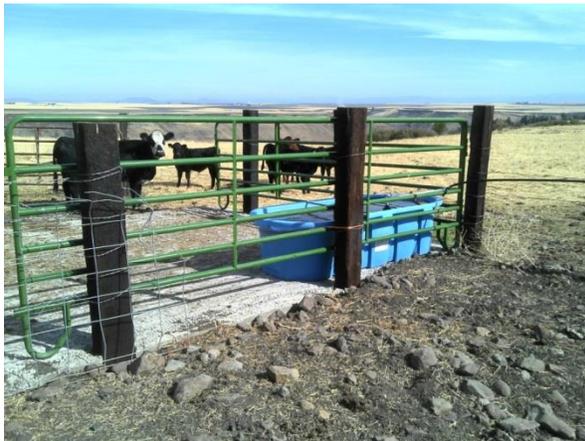
Figure 76. Two heavy-use concrete pads were installed.

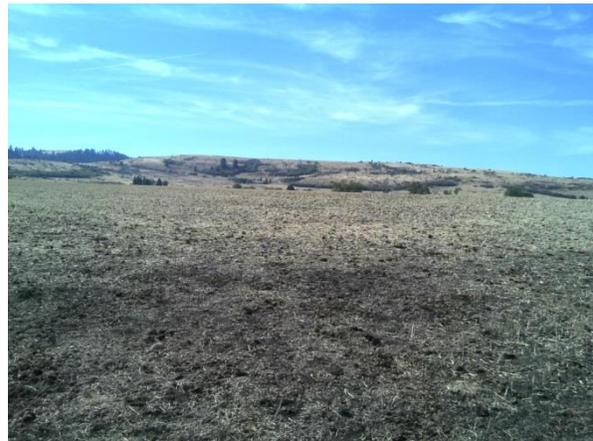
Figure 77. Project involved seeding 50 acres of reclaimed pasture with grass and forbs.

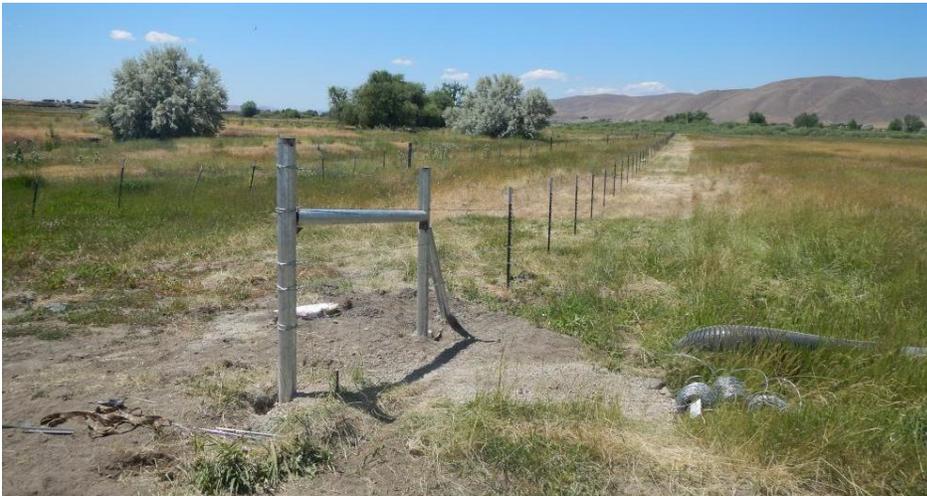
Figure 78. A fence is being installed along Cove Creek to exclude cattle and allow the riparian area to re-establish. The plan calls for fencing 1.25 miles of Cove Creek for riparian protection and grazing management.

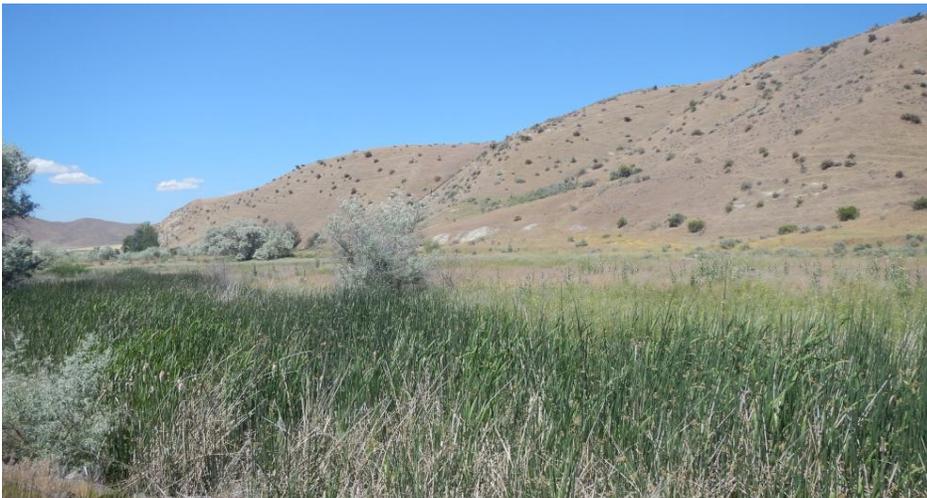
Figure 79. Plans for this area include constructing three sediment ponds and two grow plots. The wetlands will treat phosphorus, particularly orthophosphate.

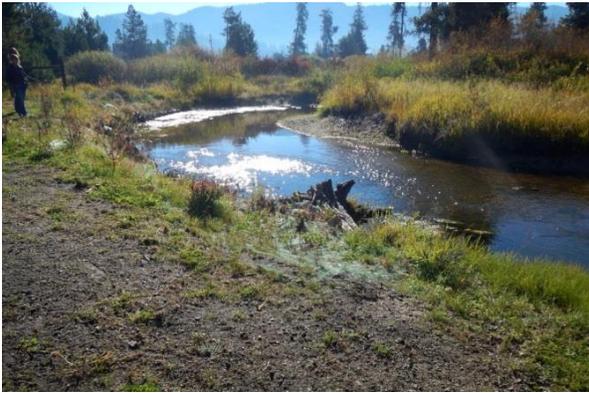
Figure 80. This root wad barb was strategically placed to deflect flow and reduce bank erosion by decreasing near-bank slope, water velocity, stream power, and sheer stress.

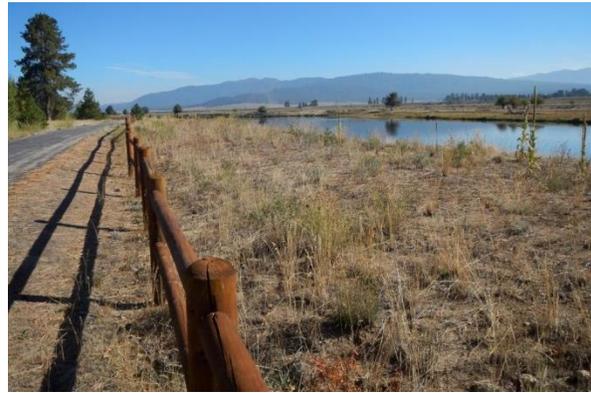
Figure 81. This pole and rail fence was installed by a Cascade High School construction class. The 1,321-linear-foot fence runs along a high-traffic public trail near the bank of the North Fork Payette River. The fence restricts access to the highly erodible streambank. To protect the bank further, hundreds of trees and shrubs were planted and cared for by the Cascade High School advanced biology and advanced research lab classes.

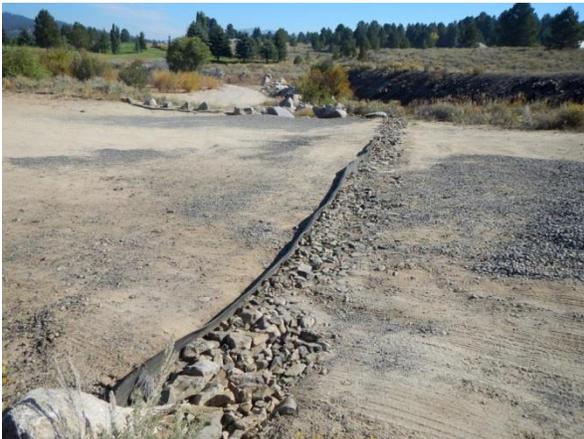
Figure 82. French drains were installed in a parking area close to the North Fork Payette River, a popular recreation destination, to help manage stormwater runoff. The 3–4 foot deep drain is lined with geotextile fabric and the trench is armored with rock. Stormwater runoff is now diverted to the basin seen in the background of this photograph.

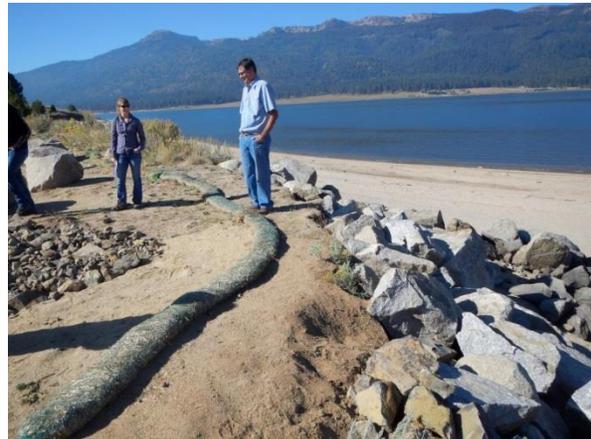
Figure 83. Rock was used to provide slope stability. School groups volunteered to plant these areas next spring with plants obtained from the Aberdeen Plant Materials Center in Aberdeen, Idaho.

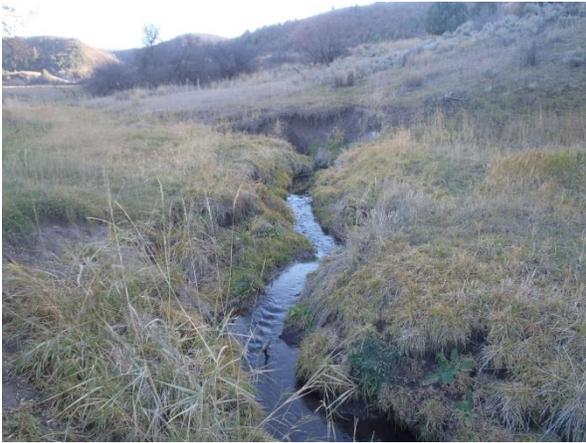
Figure 84. This photo shows the lack of woody vegetation along the stream channel and a stretch of the bank that has collapsed and fallen into the channel.

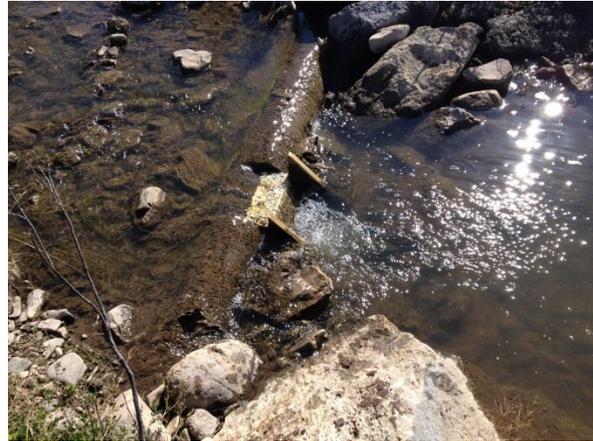
Figure 88. Instream grade control with integrated water intake structure moves water to an off-stream trough.

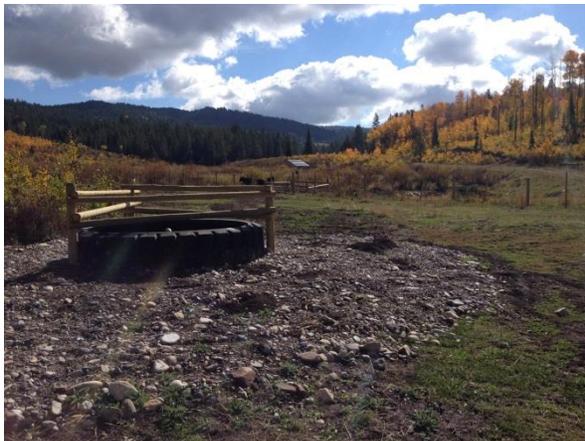
Figure 89. The solar pumping plant seen in the background powers the off-stream livestock-watering trough.

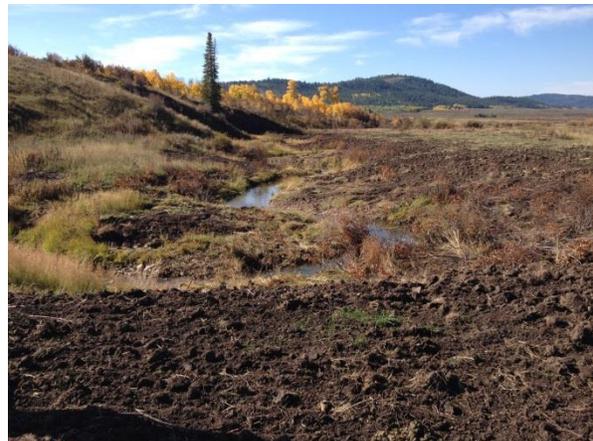
Figure 90. A view of the active channel restoration effort (fall 2014).

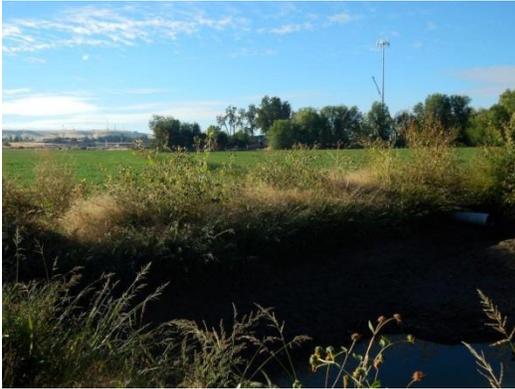
Figure 91. The sediment basin in the foreground captures runoff from a 20-acre parcel.

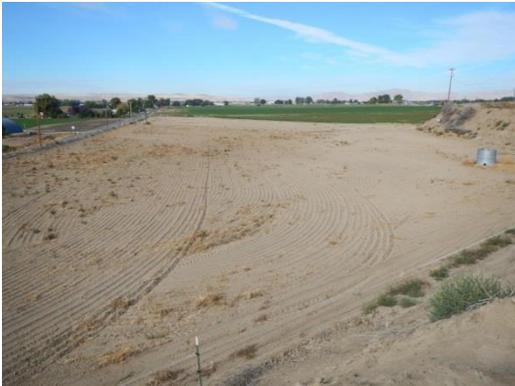
Figure 92. A potential future project site, this highly erodible parcel has a 4% slope that has historically been flood irrigated. Tail water from the site is pumped back into the Payette Ditch, which is located to the right in the photo, on top of the bank. The proposed treatment calls for establishing permanent pasture on this site and irrigating it with sprinklers.

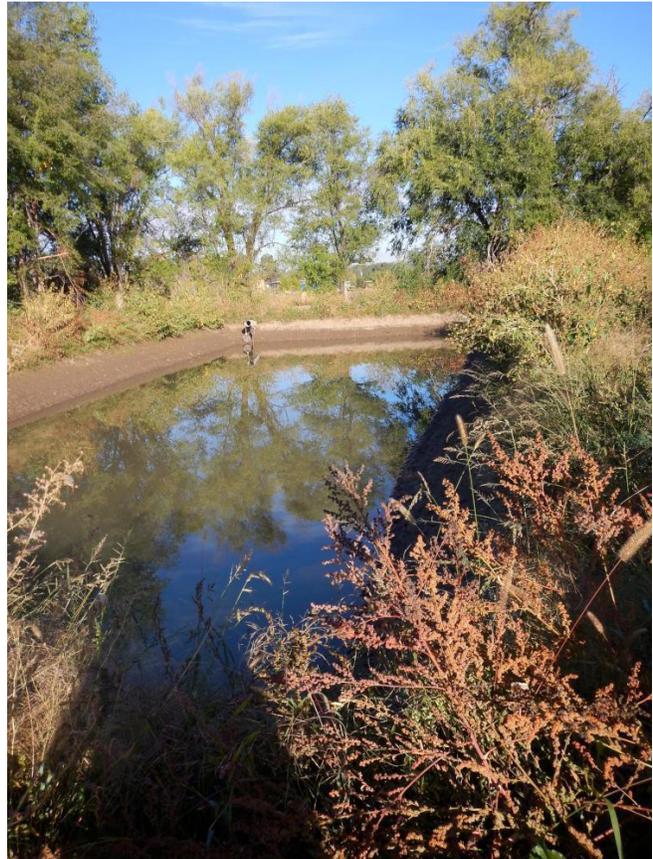
Figure 93. This sediment basin receives runoff from 20 acres of furrow-irrigated cropland and eventually discharges directly back to the Lower Payette Ditch. The ditch eventually discharges to the lower Payette River.

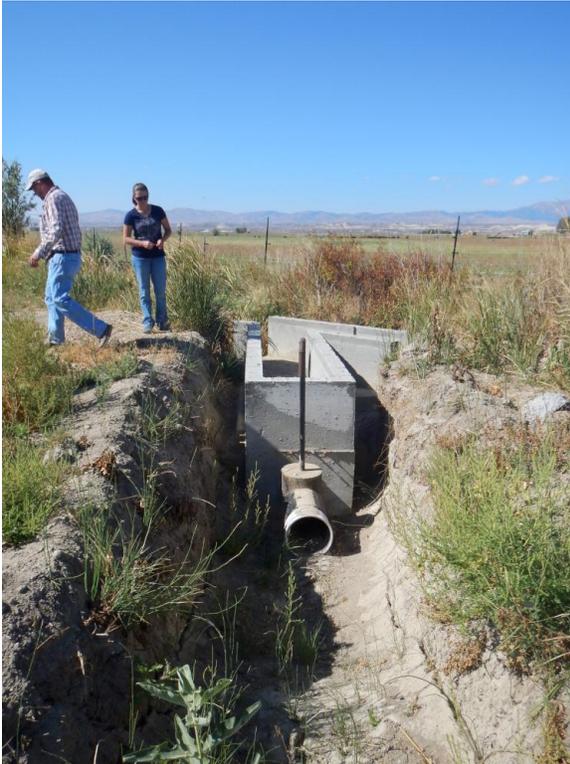
Figure 94. From this inlet structure to the pivot involves a 15-foot fall; 2,200 feet of 12-inch pipe will be used to supply water for pivot irrigation. Pivot irrigation has eliminated any discharge to Castle Creek from this site. The more efficient delivery system also allows more water to remain in Castle Creek.

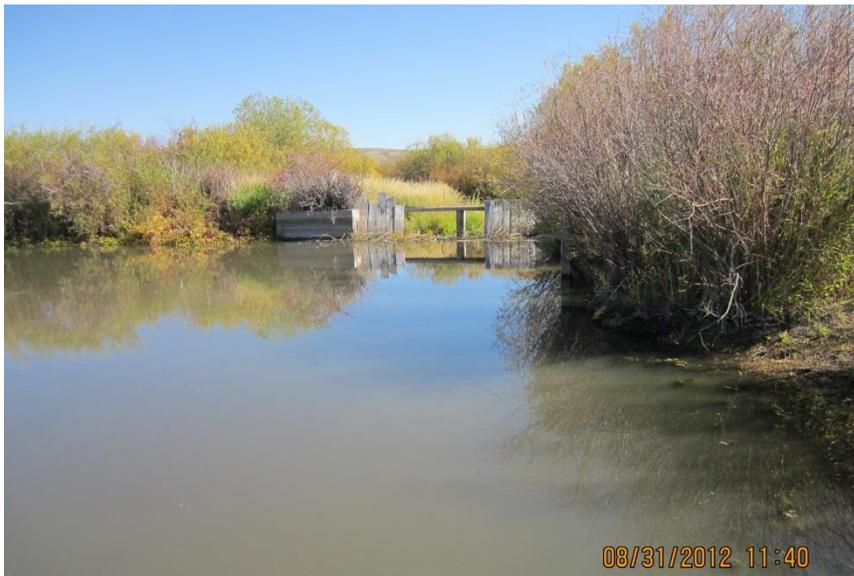
This project consists of upgrading and repairing an irrigation diversion to prevent ongoing bank erosion and better manage water withdrawals. The current diversion presents a barrier to upstream fish migration. The upgrades will allow water use to be managed on a week-to-week basis. Diverted water will slowly flow back into the channel downstream of the diversion to prevent negative impacts on aquatic life.

Figure 96. Photo looking downstream at the diversion.
