2014 Performance and Progress Report

State of Idaho Nonpoint Source Management Program

**State of Idaho
Department of Environmental Quality**

March 2015

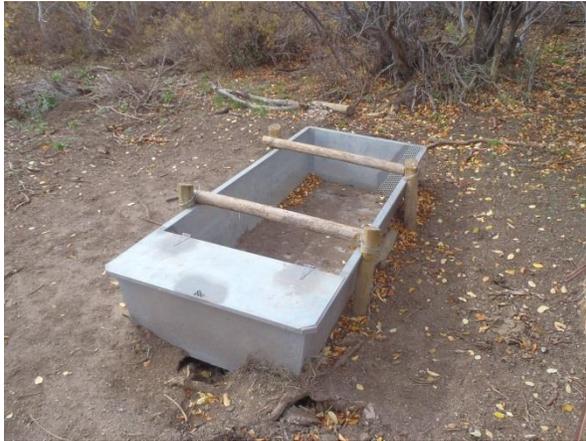
Figure 98. One of the eight troughs installed under the two contracts.

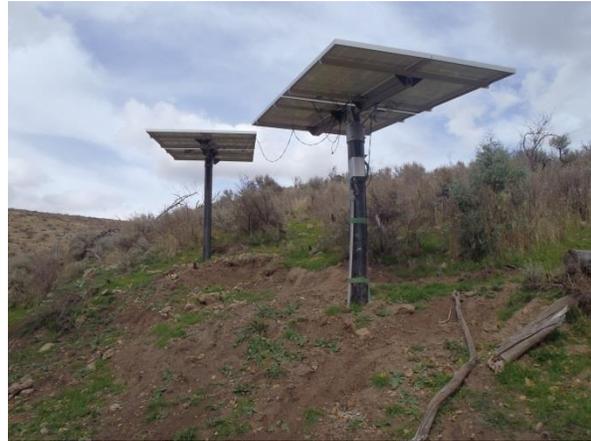
Figure 99. Solar panels on a hill above the spring power pumps to supply water to nearby troughs.

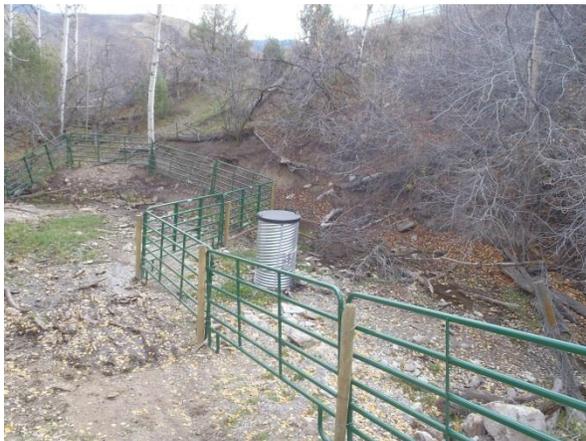
Figure 100. The spring and spring development box surrounded by exclusion fence to keep animals out.

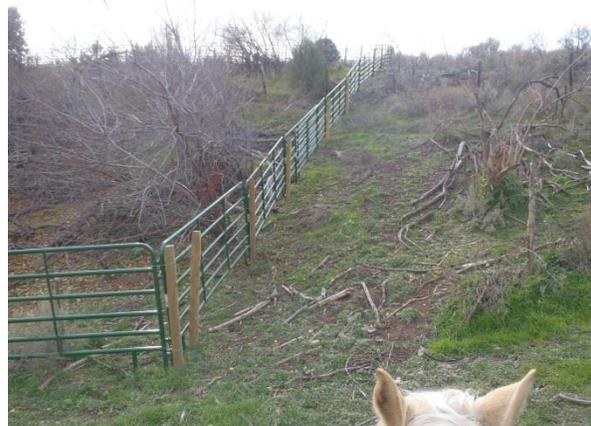
Figure 101. An exclusion fence constructed around the area of spring development is intended to keep animals out of the spring. Because of snowdrifts in this area, the Oneida Soil and Water Conservation District fenced a larger area to lessen the chance of snow pushing the fence over.

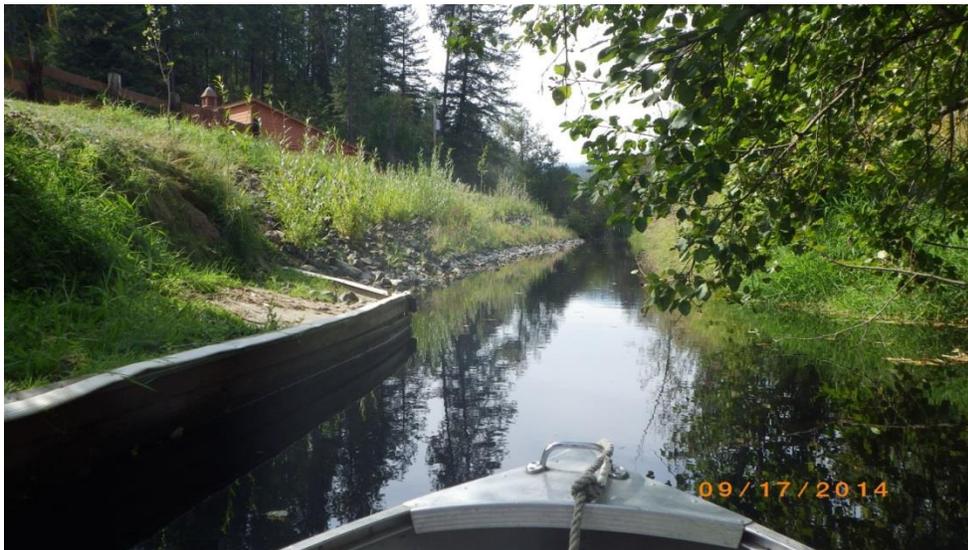
The landowner is watering the riparian plants, which has allowed them to establish root structure. Photo monitoring is being done by the Kootenai-Shoshone Soil and Water Conservation District and landowner.

Figure 102. Looking upstream at bank stabilization project.

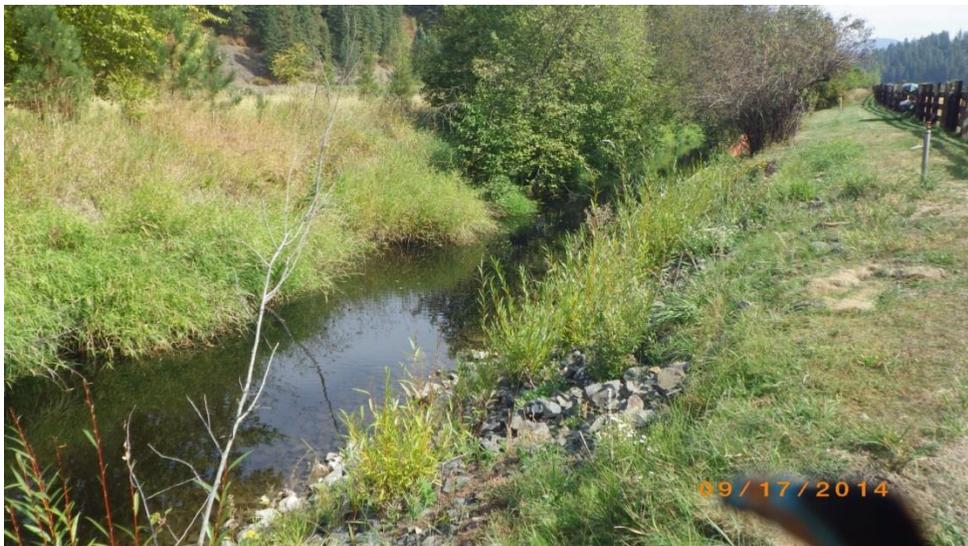
Figure 103. Looking downstream at bank stabilization project.

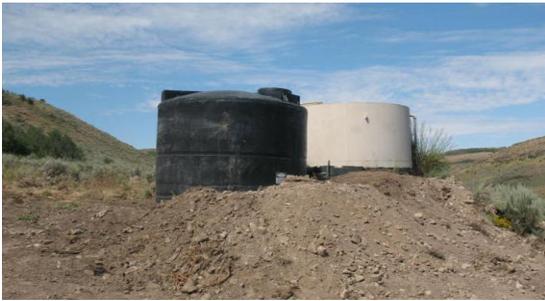
Best management practices have only been in place a short time and are in good condition. The day-to-day grazing operation is managed by Western Stockgrowers, with regular oversight by Snake River Soil and Water Conservation District and US Forest Service staff.

Figure 104. The black 6,000 gallon tank was installed on site next to a previously installed tank. The second tank increased the storage capacity by two-thirds, ensuring the cattle have an ample supply of clean water throughout the season.

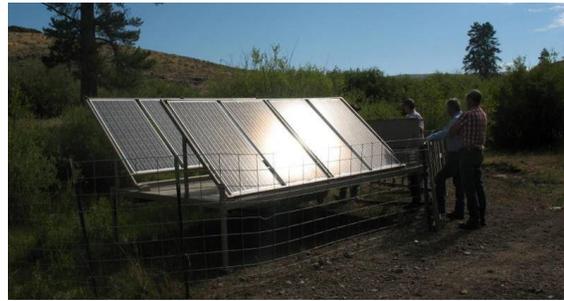
Figure 105. Eight 45-watt solar panels were attached to a portable trailer. The panels generate enough power to run the 30-gpm pump for 12 hours to supply water to the off-site holding tanks. Because the water is pumped out at a slow, continuous rate, there is little impact to the creek.

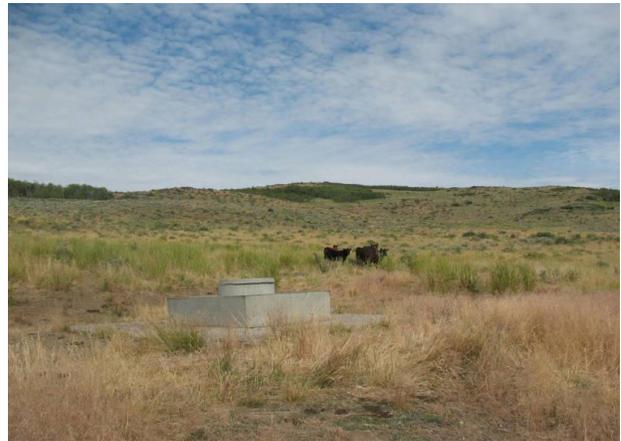
Figure 107. The two larger storage tanks supply water to over 20 smaller off-site watering tanks. The tanks are located throughout the grazing allotments, and the supply can be shut off to conserve water when cattle are moved. These tanks have been successful in providing a clean water source for cattle and wildlife, decreasing their impacts on nearby streambanks and riparian areas.

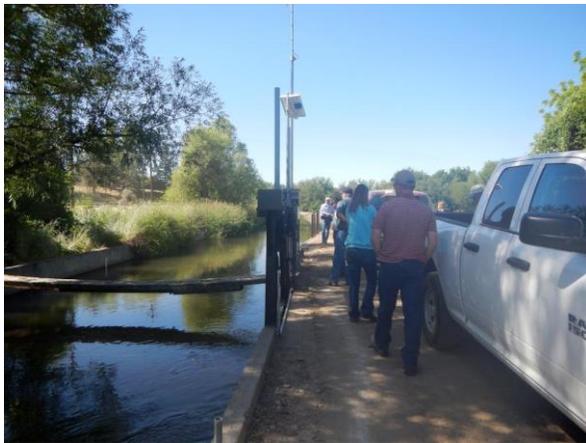
Figure 108. With the help of automated headgates, water diverted from the Weiser River is managed more efficiently. More water is left in the river to maintain higher flows, and less water is lost in the irrigation delivery and drain system. With less irrigation water returned, less sediment and nutrients enters the Weiser and Snake Rivers.

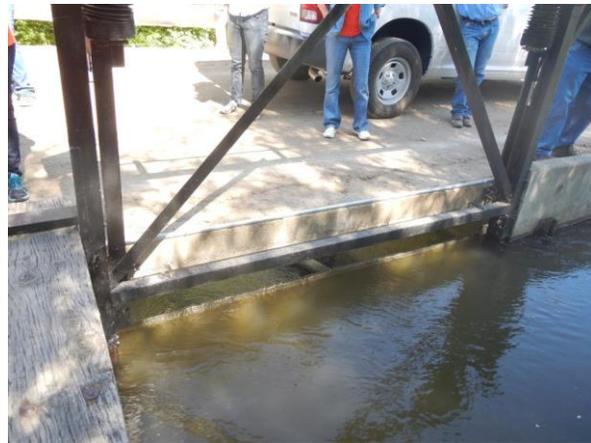
Figure 109. The automated headgate on the Galloway Canal into Monroe Creek will help to conserve water in the Weiser River, ensure adequate flows in Monroe Creek, reduce excess spill, and help maximize water delivery on demand.

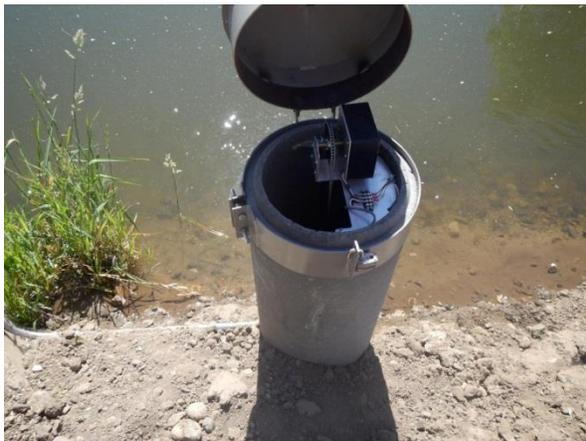
Figure 110. A still well is used with a weight and float mechanism to measure water level and provide data for automated adjustments.

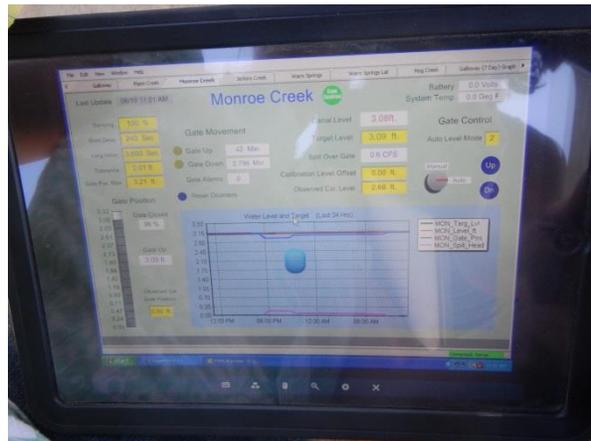
Figure 111. The data recorded by data loggers at remote sites can be viewed in real time, eliminating the need for staff to travel to these sites to collect data and make any necessary adjustments.

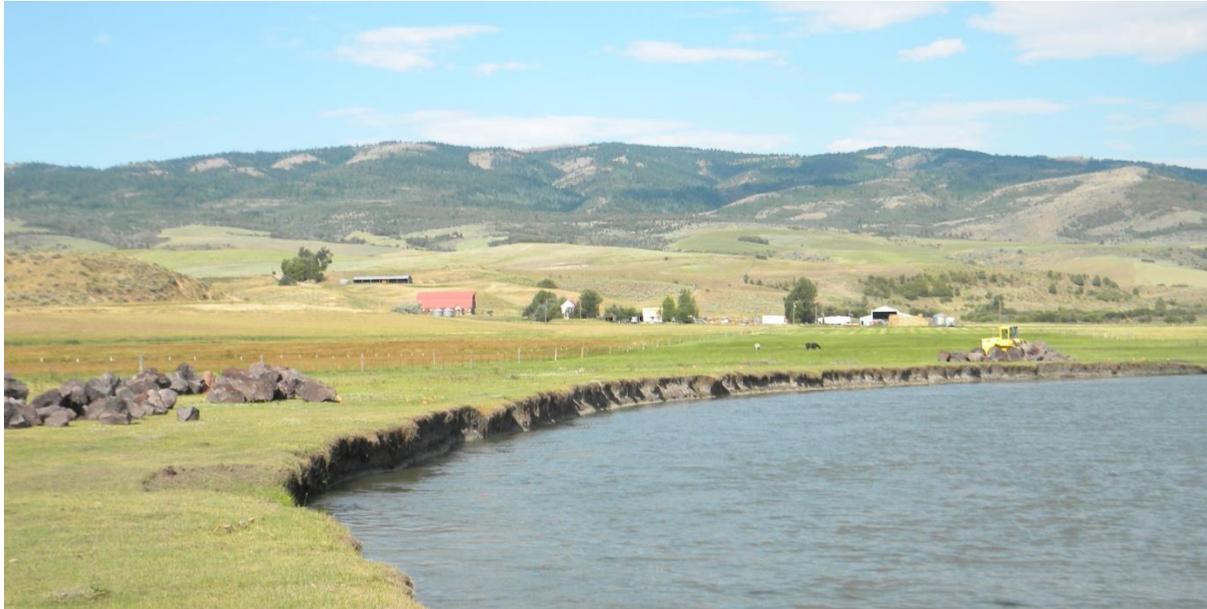
This project involves bank restoration at two sites along the Bear River. The bank along this stretch is vertical, 3 to 4 feet high, and consists of very fine material. To repair the banks, barbs will be placed at two sites in the channel to deflect flow away from the bank. Most of the work has been completed, and the landowner has been reimbursed. One landowner still must install some barbs on his stretch of the river to keep the project on schedule.

Figure 112. Rock was placed on the bank near where each barb will be installed in the river.

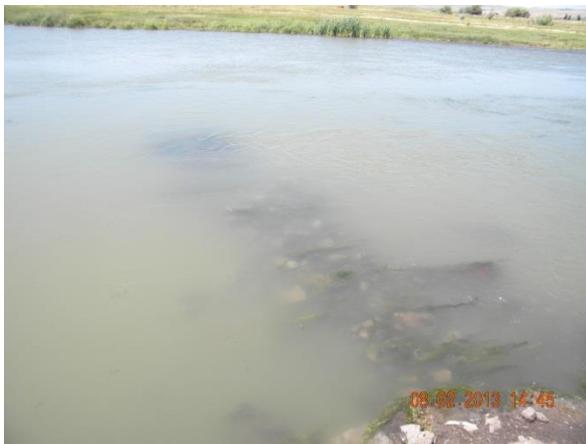
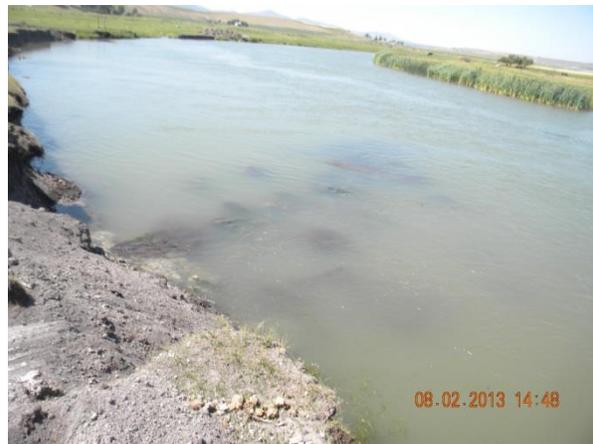
Figure 113 and 114. Installed barbs.

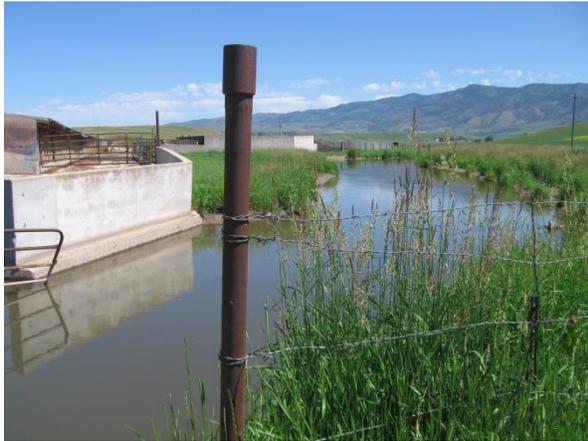
Figure 115. Looking upstream on Trout Creek. The cement wall in the foreground will be removed and the streambank restored.

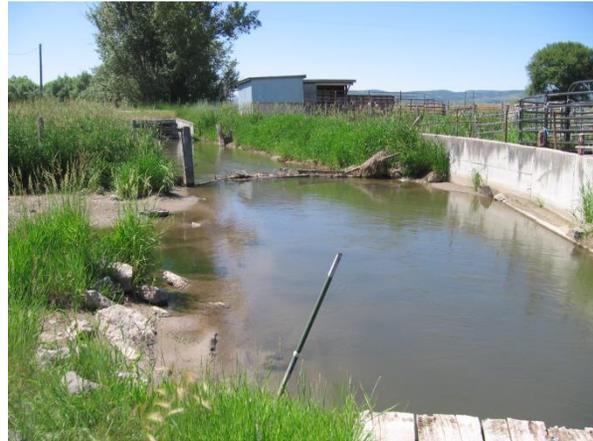
Figure 116. Looking downstream on Trout Creek. The cement wall seen in this photo will be removed and the streambank restored. Located at the downstream end of the wall is a waste storage pit that will also be removed.

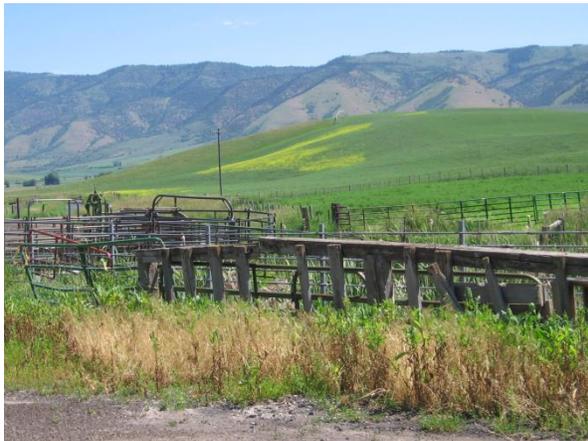
The landowner has been removing old corrals. No best management practices have been installed at this point. Monitoring is being performed on this project.

Figure 117. These corrals will be removed.

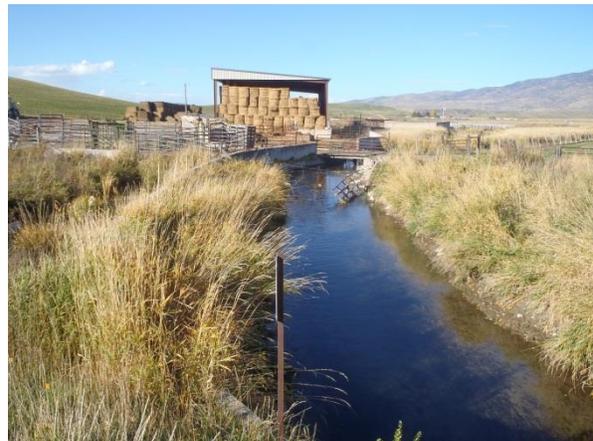
Figure 118. Removing loafing sheds and relocating the corrals was part of the project, but a fire destroyed the loafing sheds. A new hayshed was constructed at the site.

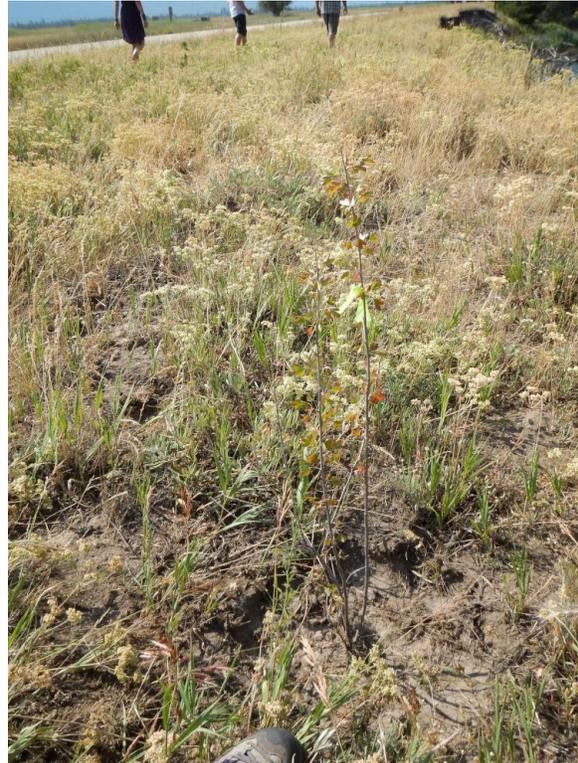
Figure 120. Alzar is partnering with IDFG to select and plant upland foliage as part of the restoration efforts. Runoff and erosion can be reduced if an effective upland buffer zone can be established.

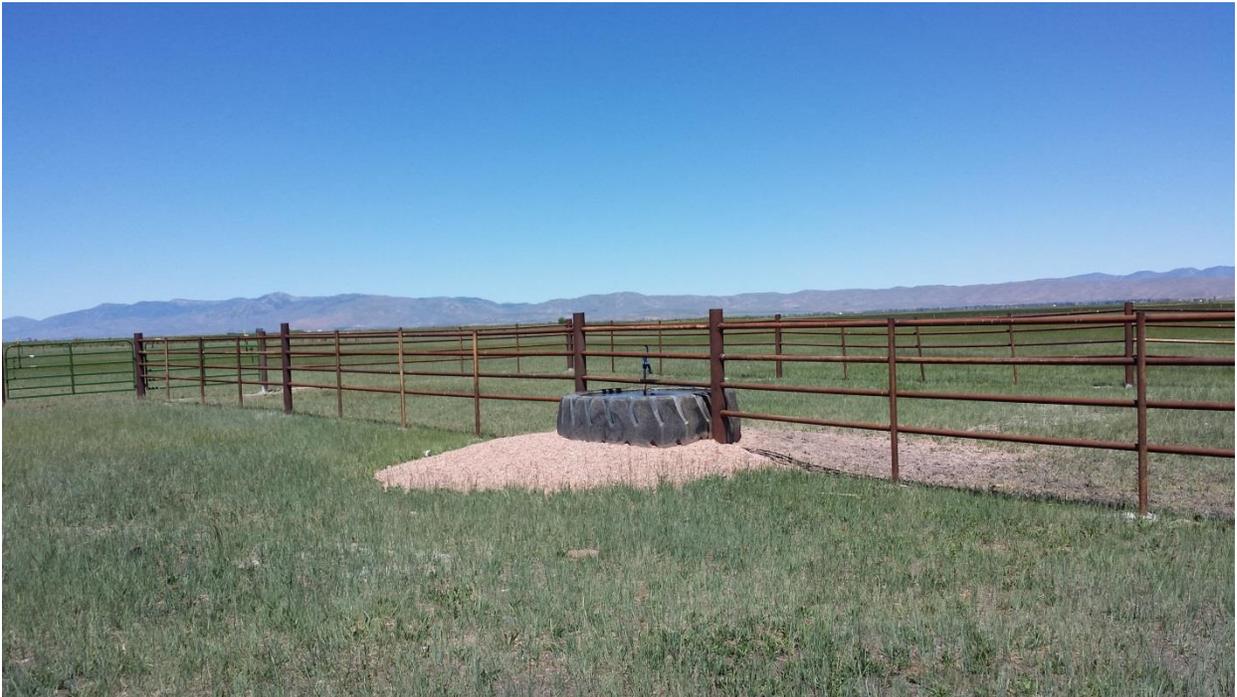
Best management practices are being maintained since the last visit. Monitoring is being performed on this project. Before and after photos have been taken.

Figure 121. New corrals were relocated away from the stream, and new water troughs were installed.
